Failure Analysis for the Economizer Tube of the Waste Heat Boiler

TSUNG-FENG WU

*New Materials Research and Development Department
China Steel Corporation*

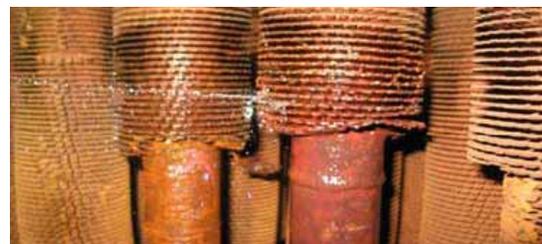
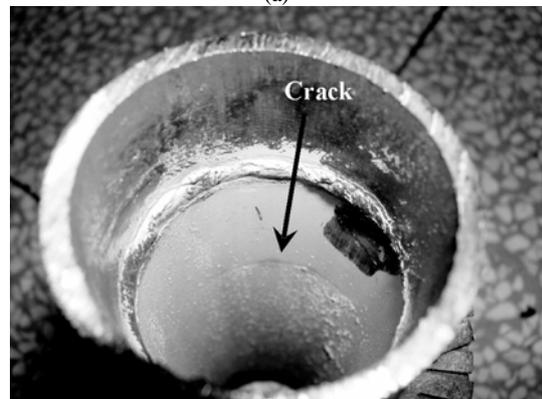
Fig. 1. Appearances of the failed tube: (a) leakage location; (b) internal evidence of crack.

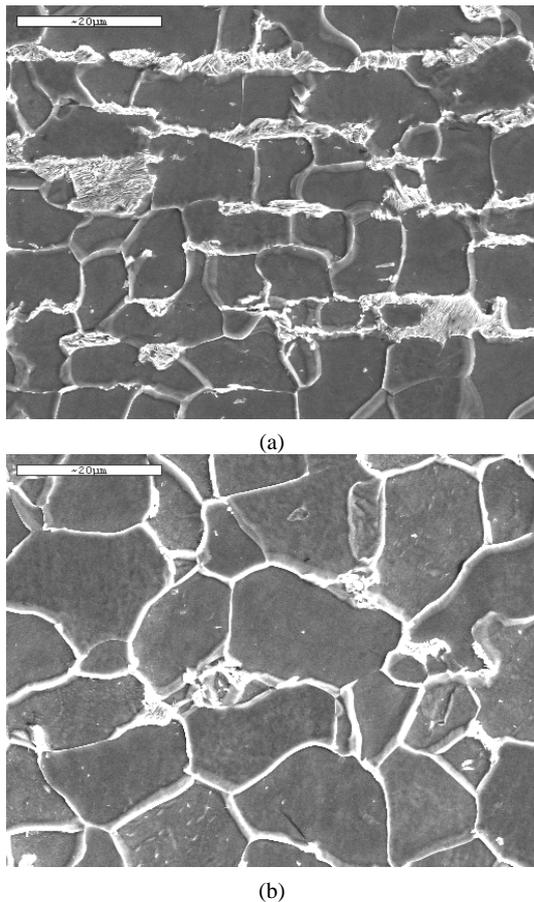
The microstructures of these two tubes were observed by using SEM examination. Figure 2 shows the cross-sectional SEM micrographs of the new tube and the failed tube after proper etching. Both micrographs reveal the band structure composed of alternate white ferrite and black pearlite phases. However, there was still slight discrepancy between these two tubes. The proportion of black pearlite in the new tube seemed higher than that in the failed one. The failed tube did not exactly display the band structure, but showed a partially equi-axied grain (Fig. 2(b)). Besides, the failed tube exhibited a grain size slightly larger than the new one. Overall, the above result implies that the failed tube was affected by the high temperature.

Fig. 2. Cross-sectional SEM micrographs of the economizer tubes: (a) new tube; and (b) failed tube.

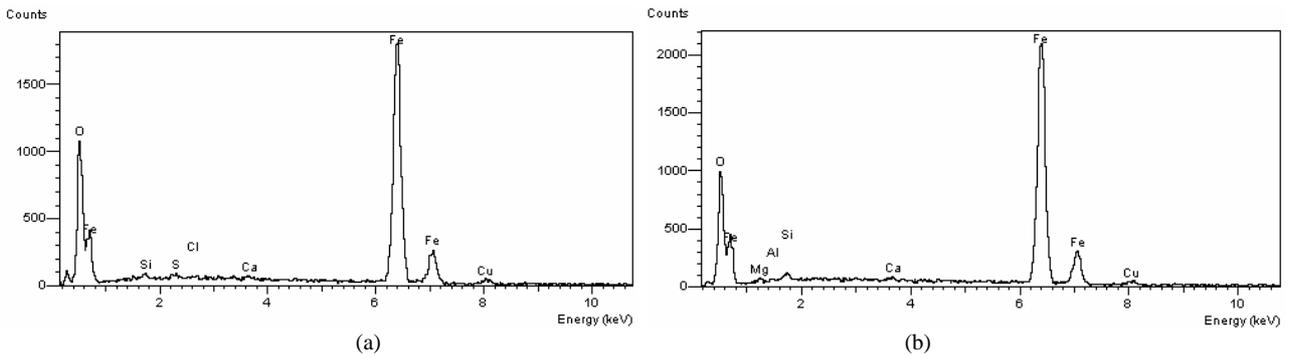
Figures 3 and 4 demonstrate the EDS and XRD analysis results of the corrosion products obtained from the outer and the inner surfaces of the failed tube, respectively. It is clear that, no matter whether found on the outer or the inner surfaces, the corrosion products are mainly composed of Fe and O which was identified as Fe_2O_3 from XRD analysis. Additionally, the slightly larger content of S found on the outer surface should come from the surrounding waste-heat atmosphere. In addition to Fe_2O_3 , α -Fe was also detected in XRD signal of the corrosion product on the inner surface, indicating the thinner oxide layer formation. It is realized that the thinner oxide film on the inner surface resulted from the lower temperature due to the cooling of the flowing fluid. The above result reveals that, on both the inner and the outer sides of the economizer tube, there were no obvious aggressive corrosives from the environment.

Fig. 3. EDS analyses of corrosion products obtained from different locations of the failed tube: (a) outer surface; and (b) inner surface.

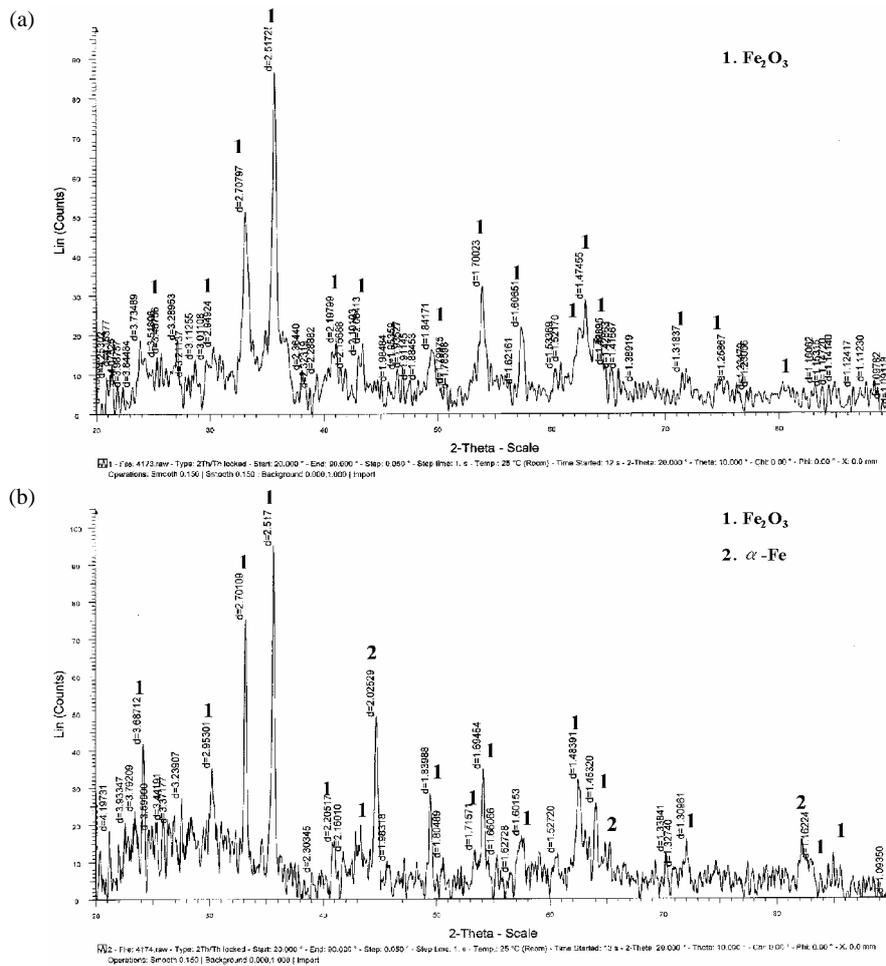
Fig. 4. XRD analyses of corrosion products obtained from different locations of the failed tube: (a) outer surface; and (b) inner surface.

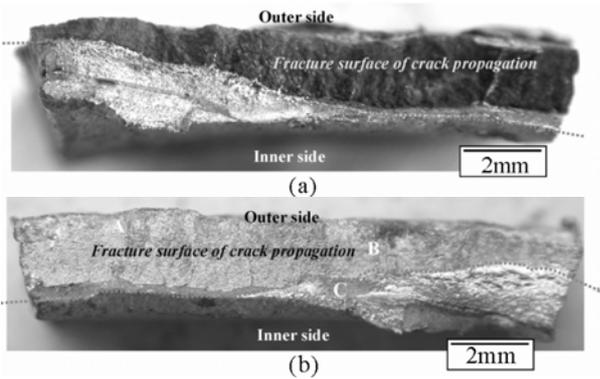
With visual inspection, the fracture part of crack propagation appeared dark. The lower left fracture surface, showing metallic brightness, resulted from artificial impact after immersion in liquid nitrogen

(Figure 5(a)). SEM was also performed to examine the morphology of the fracture surface. However, due to the actual fracture surface being covered by oxide (the darker area), the fracture type could not be observed and identified. Therefore, the oxide was removed to explore the real morphology of the fracture surface.

Figure 5 (b) shows the fracture surface appearance of the failed tube after descaling. The region above the dotted line in the figure was the original darker region. SEM was also performed to observe the morphology of

Fig. 5. The fracture surface appearance of the failed tube: (a) before descaling; and (b) after descaling.

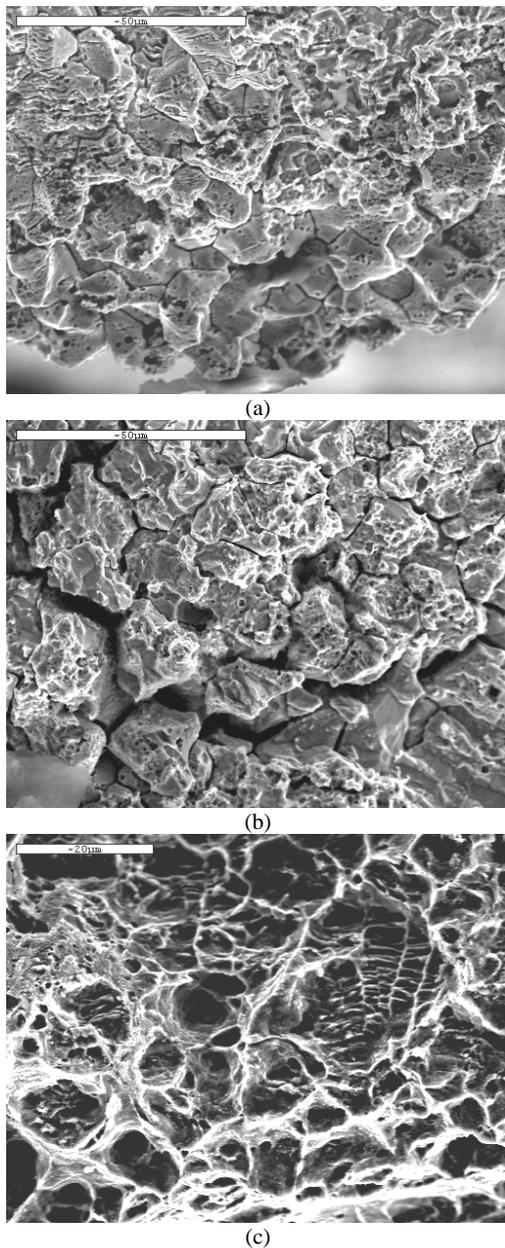
the fracture surface in detail. Fig. 6(a)~(c) are SEM micrographs at higher magnification for spot A~C, as designated in Fig. 5(b), respectively. Both spot A and B, located in the crack propagation region, revealed intergranular fracture (Figs. 6(a) and (b)). In other words, the fracture type through the whole region of the crack propagation surface was identified as intergranular. However, the fracture surface resulting from the artificial impact revealed a dimple morphology, as shown in Fig. 6(c).

Fig. 6. SEM micrographs at higher magnification for: (a) spot A; (b) spot B; and (c) spot C, as designated in Fig. 5(b).

Therefore, the failure can be prevented by using qualified materials, applying post weld heat treatment (PWHT) on the welded tube, and reducing the frequency of the start-stop cycle, if possible.

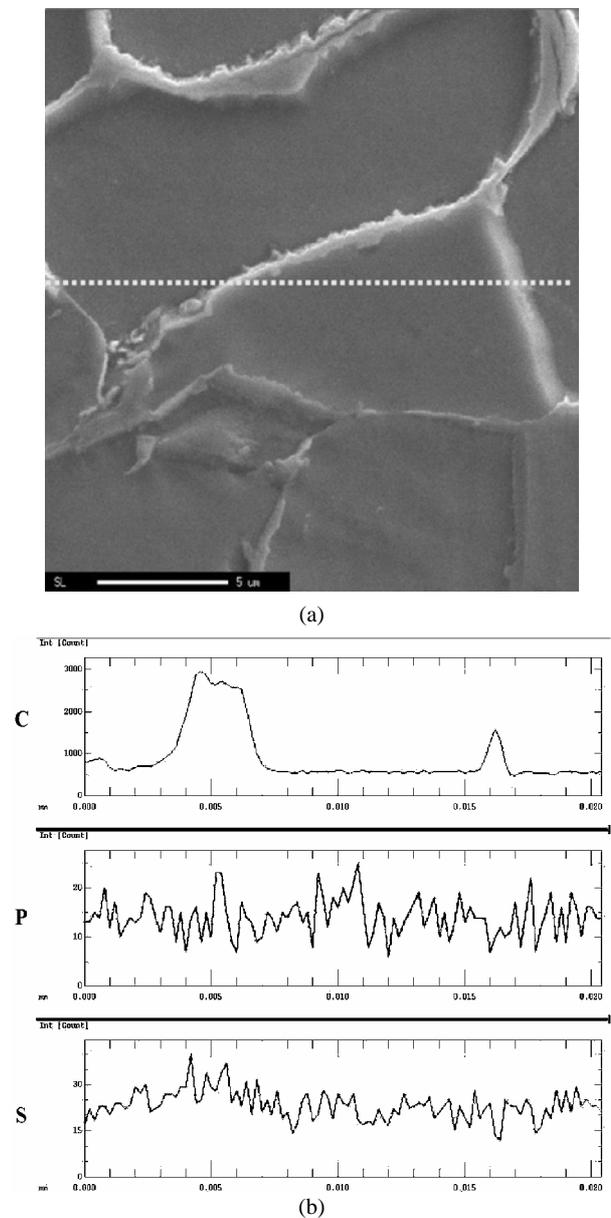
Generally, the formation of the intergranular fracture always corresponded to the metallurgical degradation or the elemental precipitation in the vicinity of the grain boundary. Therefore, in this study EPMA line scanning analysis was performed to evaluate some specific element distribution near the grain boundary of the failed tube. The result is shown in Figure 7. From Figs. 7(a) and (b), it is clear that two C signal peaks located in the grain boundaries showed carbide precipitation. Furthermore, a slightly higher intensity of S was also detected in the grain boundary. However, the content of P was independent of the locations along with the yellow dotted line in Fig. 7(a).

Fig. 7. EPMA line scanning analysis of failed tube: (a) SEM micrograph; and (b) C, P and S content distribution along the yellow dotted line in Fig. (a).

As mentioned above, although the material and mechanical properties of the failed tube, including chemical composition and metallurgical structure, were inferior to those of the new one, most of them still satisfactory met to the criterion requirement. Therefore, the crack formation did not result from the overall degradation in the particular tube. For the failed tube, the S content reached 560 ppm, which was almost twice the standard value (350 ppm). The degradation in toughness for the failed tube was due to the higher S content as expected. Besides, the type of crack propagation was identified to be intergranular, leading to the mechanical or metallurgical degradation in the grain boundary in a local region. The EMPA result demonstrated that the carbide precipitation and sulfur segregation took place in the grain boundary.

Carbides in steel can be precipitated in the grain boundary after thermal treatment in the range of 650~750 . In addition, in the temperature range of 400~550 , sulfur is more easily segregated in the grain boundary if its content is higher than the normal, such as in the failed tube of this study. Both intergranular carbide precipitation and sulfur segregation will lead to a decrease in toughness.

The crack formation might result from a combination of a decrease in the toughness, due to carbide precipitation and/or sulfur segregation in the grain boundary, and thermal fatigue due to the daily start-stop cycle. However, the actual operation temperature of the economizer tube was 140 which could not induce carbide precipitation and sulfur segregation. Therefore, the toughness degradation in the grain boundary must have taken place during the fin welding process. Toughness degradation due to an unsuitable welding process is generally called weld decay.^(2,3)
