# Failure Analysis of Coating Adhesion: Peeling of Internal Oxidation Layer over Electrical Steel after Stress Relief Annealing

New Materials Research & Development Department  
China Steel Corporation

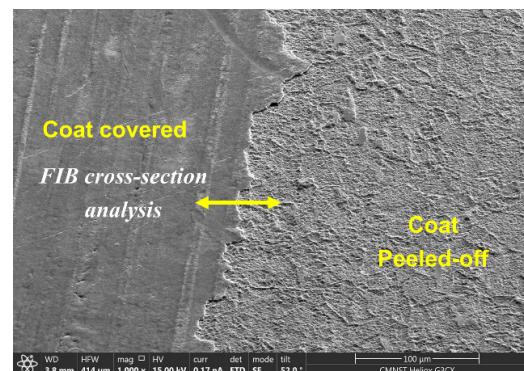
In order to realize the mechanism of coat peeling, tape tested sample A was first examined. Figure 2 demonstrates the SEM image of peeled-off sample A. From the top view of the sample surface, it can be clearly identified that the right hand side of the image was the bare ES substrate. The uncoated ES substrate should be flat with low surface roughness. However, after the heat treatment of the ES, a high degree of surface roughness of bare substrate was present. Due to high surface roughness, the peeled-off area showed a foggy white color to the naked eye. By selective etching of gallium ion, we were able to observe the cross-sectional region of sample A. Figure 3 demonstrates the cross-sectional images of SEM and SIM respectively. From the electron image, a small crack could be observed beneath the coat layer. However, by observing the contrast-enhanced ion image, we could further notice that the heat-treated ES was actually consist of three different layers of structure.

Fig.2. SEM top view images of peeled-off sample A.

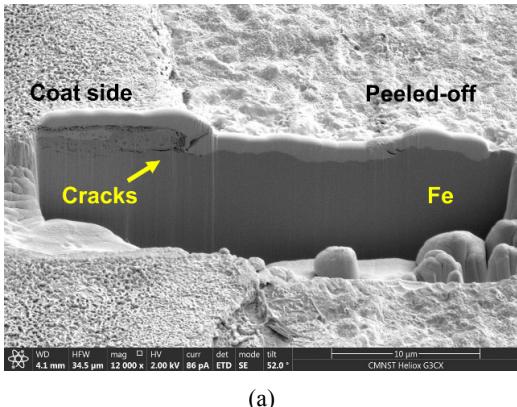
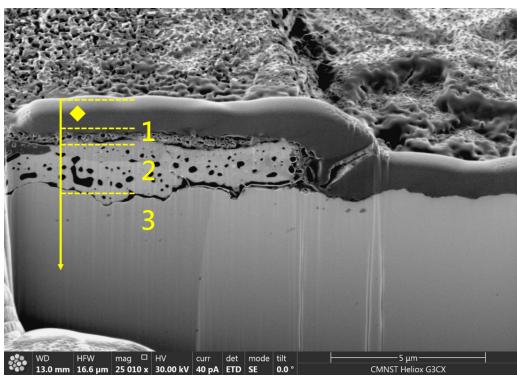
**Fig.3.** Cross-sectional images of peeled-off sample A. (a) SEM (magnification, 12,000×); (b) SIM (magnification, 25,010×).

However, the black dots are composed of high concentration of Si, Al and O, suggesting that these were the mixtures of silicon oxides and aluminum oxides<sup>(9)</sup>. Furthermore, these oxides were further aggregated into a continuous, worm-like structure, enriched at the bottom of the IOZ. Thirdly, the bottom layer is the original ES substrate, namely Si-Fe alloy. Unexpectedly, the cracks, which led to the occurrence of fracture, located

at the interface between the IOZ and ES substrate. It is suggested that the adhesion of these oxides and ES was poor. When the IOZ was peeled from the substrate, there was no possibility that the coats could still remain on the surface.

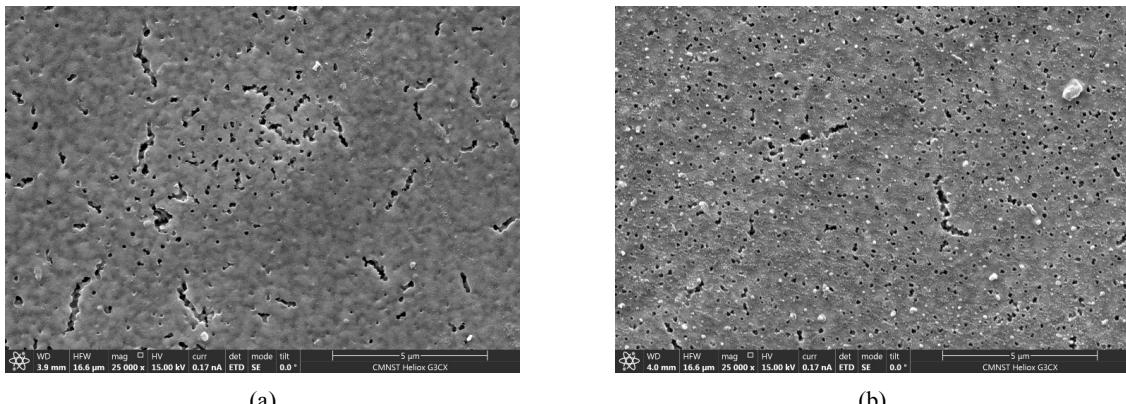
To identify the characteristics of peeling morphology, two untested samples, peeled-off sample A and well-attached sample B, are thoroughly studied in this section. Figure 4 demonstrates the top view SEM images of sample A and B. After heat treatment, some cracks and pinholes were discovered on both surfaces. Since the coat contained polymer resins, the organic parts were eventually decomposed into volatile species. When these small molecules diffused out from the coat film, it could form the structure of cracks and pinholes. Generally speaking, two samples showed different morphologies. Sample A contained more cracks than sample B, however, sample B contained more pinholes than sample A. It may suggest that the decomposition rate of coats in two furnaces were slightly different.

**Fig.4.** SEM top view images of untested (a) sample A and (b) sample B.

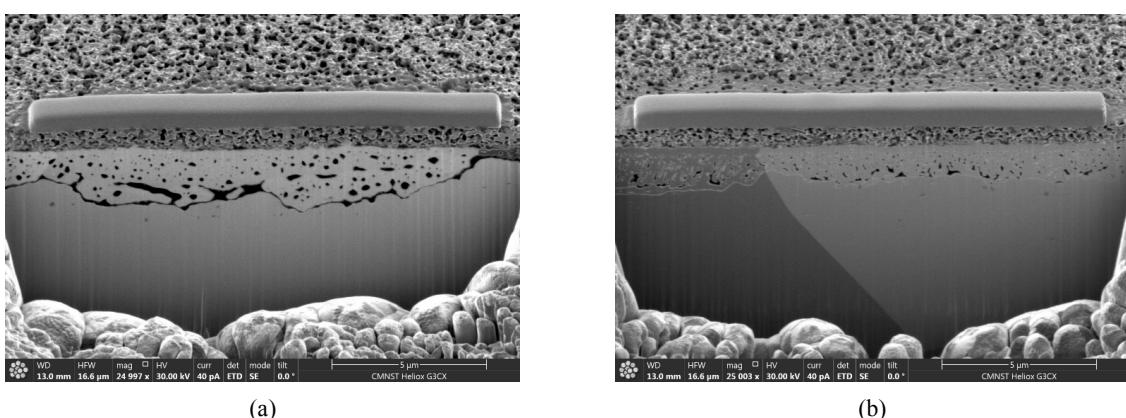
Figure 5 shows the cross-sectional SIM images of untested sample A and B respectively. The result indicated that sample A contained much higher concentration of oxides than sample B. Moreover, the thickness of the IOZ of sample A was also thicker than sample B. Figure 6 presents the elemental depth profiles of sample A and B by GDS. With the assistance of cross-sectional images, the boundaries of each layer could be easily identified. The thicknesses of the first coat layer of the two samples were nearly identical. However, the second layers showed a great difference in elemental distribution. In sample A, it was found that such elements like Si, Al, Mn and O had a remarkable increment as compared to sample B. This result indicated that the concentration of oxides in sample A were

**Fig.5.** SIM cross-sectional images of (a) sample A and (b) sample B.

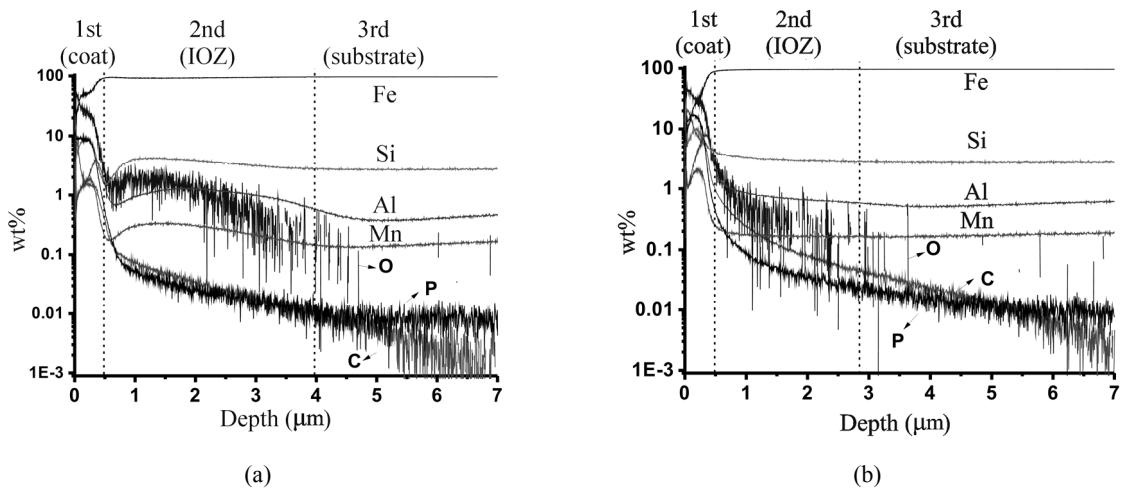
**Fig.6.** GDS depth profile analysis of (a) sample A and (b) sample B.

much higher than that in sample B, which was in agreement with the result of the cross-sectional image.

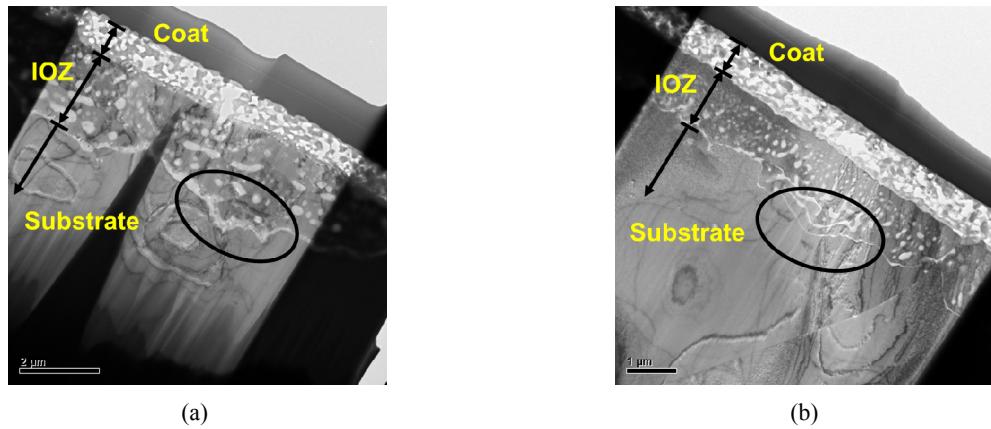
Figure 7 shows the TEM images of sample A and B. Likewise, three layers of structure could also be evidently observed. The circled areas revealed that the concentrated oxides were accumulated on the interface

between IOZ and substrate. These oxides could also be found in the well-attached sample B by observing with a high resolution TEM. However, the thickness of these oxides were relatively thin as compared to that in sample A. Figure 8 shows the corresponding EDS mapping results of TEM images. The results were consistent

**Fig.7.** TEM cross-sectional images of (a) sample A and (b) sample B.

of magnetite ( $\text{Fe}_3\text{O}_4$ ) and hematite ( $\text{Fe}_2\text{O}_3$ ). According to the references<sup>(10)</sup>, these oxides had lower coefficients of thermal expansion than iron. Significant stresses could be generated in the interfaces during the heat treatment, which accelerated the occurrences of peeling accordingly.

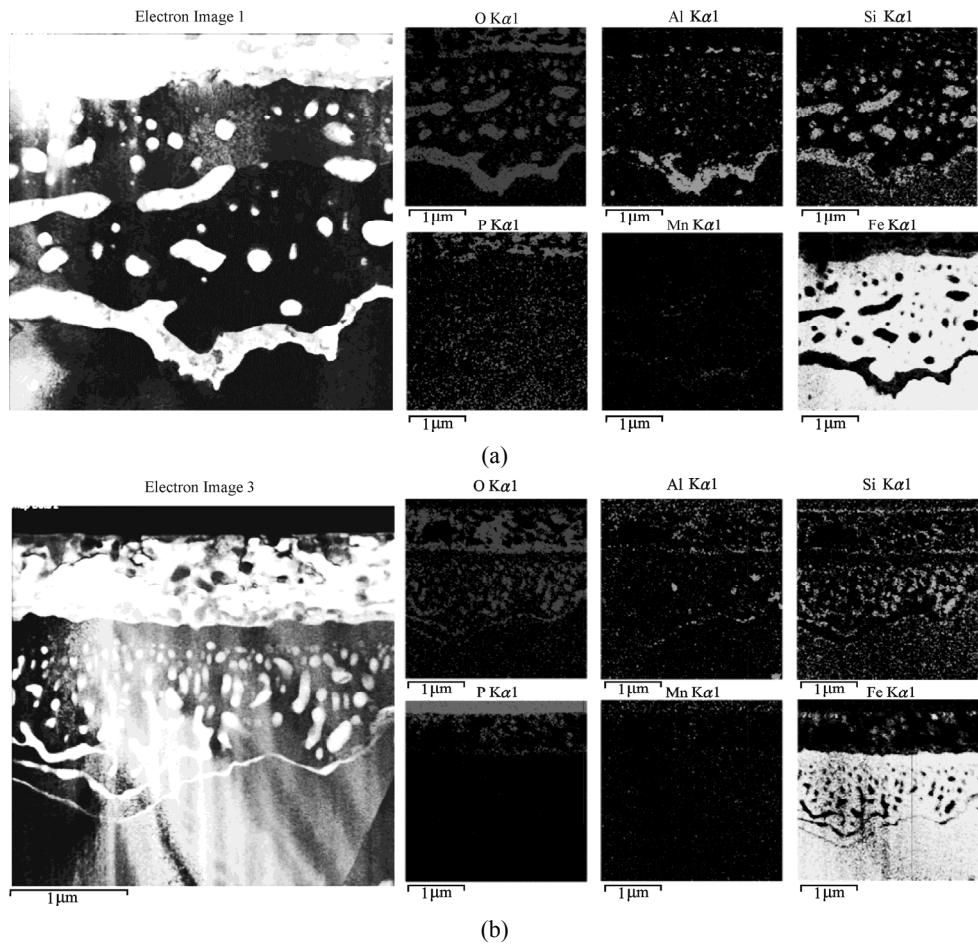
with the EDS analyses in Table 1. Particles and worm-like structure in the IOZ were mainly formed with Si, Al and O, which proved that they were mixtures of silicon oxides and aluminum oxides. Interestingly, the results of mapping further suggested that dispersed particles were primarily formed with silicon oxide, and the worm-like oxides in the interface were

majorly formed with aluminum oxides. Since Si and Al were the active elements in ES alloy, the segregation of Si and Al at the grain boundary during heat treatment would be inevitable. As contacting low partial pressure of oxygen, Si and Al could be oxidized first rather than Fe due to the reactivity. Therefore, it led to the formation of silicon oxides and aluminum oxides, instead

**Fig.8.** EDS mapping of sample A and sample B.

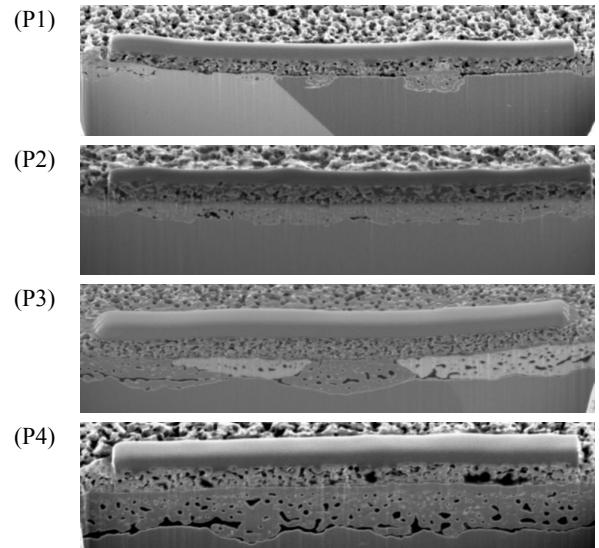
**Fig.9.** SIM cross-sectional images of samples obtained by different heat profiles.

Since the segregation of Si and Al were thermodynamically controlled, it might be possible to adjust the heating parameters to avoid the enormous peeling of IOZ. In order to clarify the effects of heating parameters on peeling, four different heating profiles were tested in this study. In Table 2, the results suggested that gas composition had a minor effect on the IOZ peeling, however, soaking time showed a major influence on it. By altering the soaking time in the annealing section, the phenomenon of peeling could be easily noticed. Figure 9 offers the corresponding cross-sectional SIM images obtained with different heating profiles. The results indicated that the formation of IOZ and worm-like oxides could be strongly related with heating parameters. In the end, this work underscored the importance of heat treatment conditions of end users. With a circumspect control of annealing environment, the adhesion failure of IOZ could be eliminated.
