Ceramic Welding for No.31 Hot Stove Wall of Blast Furnace at CSC

TAI-HU HUANG

*Ironmaking Department
China Steel Corporation*

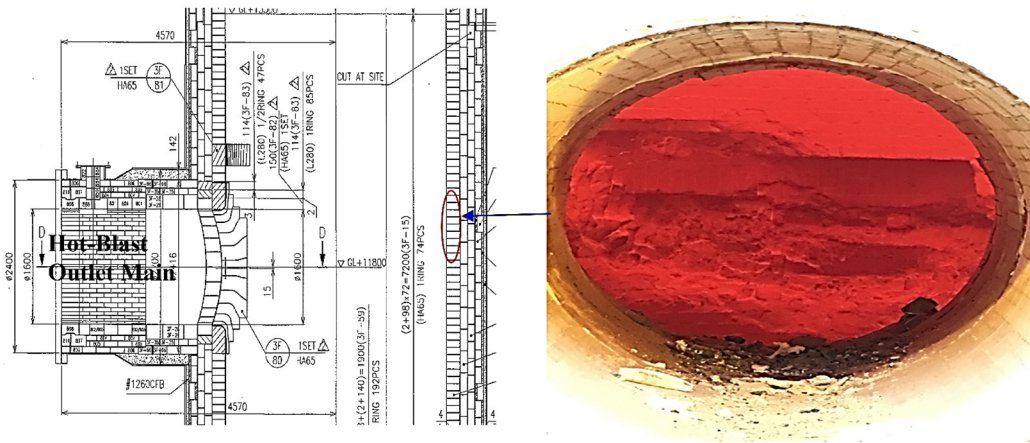
The No.3 blast furnace of CSC was revamped from Oct. 1, 2017 to Feb. 26, 2018 and the No.34 hot stove was rebuilt at the same time which was completed by May, 2019. During the revamping period, No.31, No.32 and No.33 hot stoves were insulated and the condition of the bricks of the hot blast outlet were checked. On Nov. 3, 2017, the first inspection found the damaged area near the hot-blast outlet main of the combustion chamber of No.31 hot stove, where silica brick had collapsed, revealing the porous brick insulation layer. Ten days later, the second inspection found the bricks had continuously fallen, the damaged area was about 2.5 meters width, 1 meter high, as shown in Figure 1. The lining configuration of the hot blast outlet area of the hot stove is shown in Table 1. There are 6 layers of refractory materials, from the hot blast area to the iron shell, which is respectively silica brick (SGT-N) and three layers insulating brick (SV, B6, FP23S), rock wool and unshaped refractory(CN140G). The most severe part of the damaged area was where the silica bricks (SGT-N) and porous silica insulation bricks (SV) had completely fallen, the area was about 1 m * 0.6 m, the thickness was 346 mm. The remaining bricks could have continued to fall down because the upper bricks were unsupported.

In addition, there were hot spots on the east and the northeast side of the combustion chamber shell. The

temperature exceeded to 200°C and continued to be high, which would reduce the strength of the iron shell and might even melt it. It is necessary to carry out an emergency repair to continue the function of No.31 hot stove. And also ensure the normal operation of the three hot stoves after revamping of the No. 3 blast furnace.

Fig.1. Damaged area near the hot-blast outlet main of the combustion chamber.

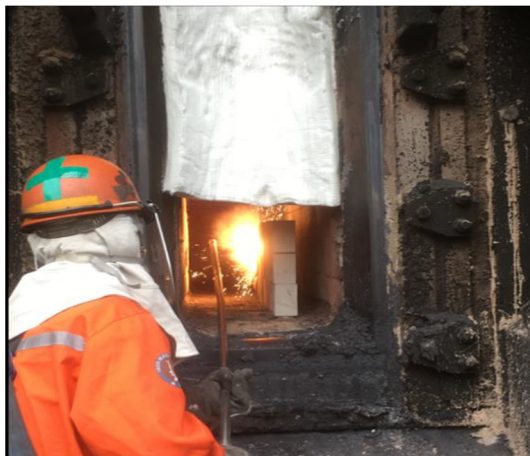
Fig.2. B6 insulation bricks where ceramic welding was carried out in the coke oven chamber.

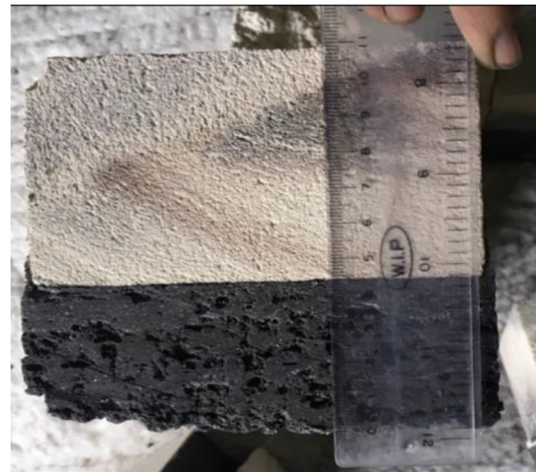
After the ceramic welding, the surface combination between the two different materials was found to be good by visual check as shown in Figure 3 and a test at the laboratory confirmed the strength of the ceramic welding material and B6 insulation brick can reach ~1MPa, the bonding strength is similar to silica brick (~1.3MPa). So ceramic welding can be suitably applied to the combustion chamber of a hot stove.

Fig.3. The surface combination between two different materials.

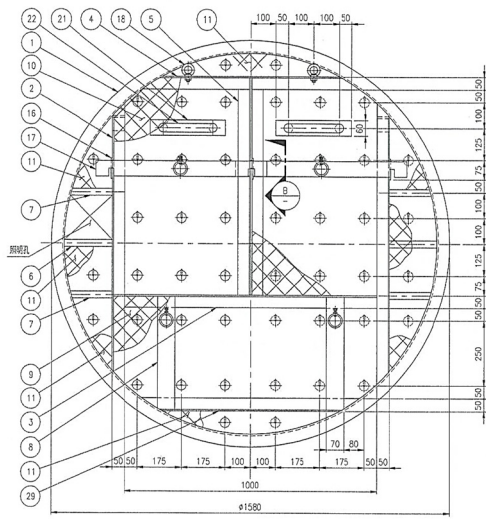
Fig.4. Sketch of the designed heat shield.

The diameter of the hot air outlet main is 1.6 meters. If the heat shield is divided into several pieces, it is not easy to fix it. In addition, the ceramic welding pipe bracket must be designed behind the heat shield. Therefore, it must be integrated into one piece. The damaged area of the brick is about 2.5 meters width and 1 meter high. The calculated width of the bracket is 1.3 meters, which can cover the damaged area. In order to control the 70kg ceramic welding pipe, the length of the bracket extends into the combustion chamber by 2 meters. The temperature of the chamber is about 1000°C. The material is made of SUS301S in order to prevent the bracket from being thermally deformed. The outer frame of the shield is bent by channel iron and the two sides of the middle frame are covered with 50mm ceramic blanket and expanded metal lath. Two openings of 500mm x 800mm on the shield are reserved. The openings can be opened according to the ceramic welding position. The designed heat shield weighs 220kg. (as shown in Fig.4)

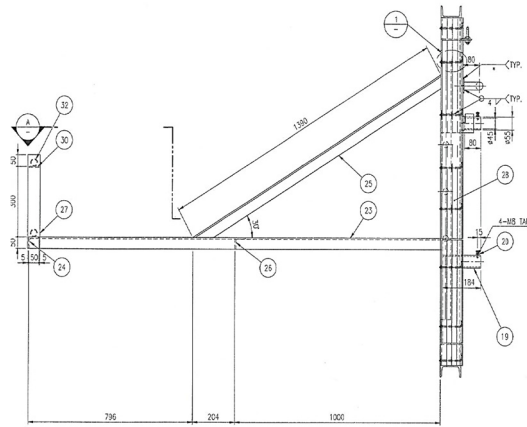
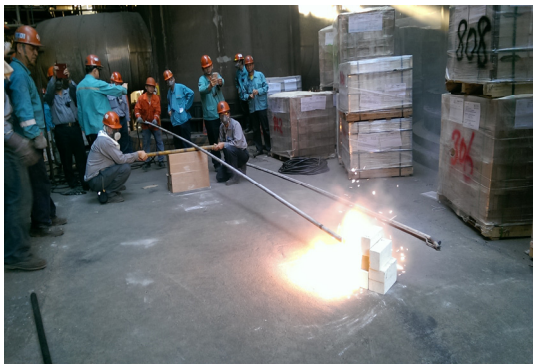
Fig.5. The spray demonstration after the water-cooled pipe was made

The methods of ceramic welding are different between the combustion chamber of the hot stove and coke oven chamber. Therefore, the ceramic welding nozzle needed to be redesigned and changed from the original 90° to 30°, and the pipe length design to 6.5 meters, and according to the coke oven ceramic welding experience, if the pipe temperature is too high, it may become blocked by the material, so 3 air-cooled and 2 water-cooled pipes were made, with SUS304 material being used. Figure 5 shows the spray demonstration after the water-cooled pipe was made.

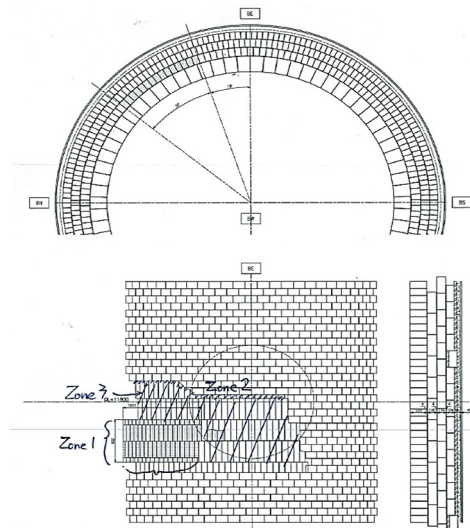
Fig.6. The damaged area identification pattern.

The critical area for ceramic welding needed to be confirmed in advance. By drawing a damage area identification pattern (Fig.6), the damaged area could be divided into three zones. The first zone was the primary repair area, which had two layers of collapsed brick as well as a hot spot area detected from iron shell. The

measurement of the area was about 1 meter wide, 0.6 meters high, ceramic welding would spray about 30~50 mm thickness in this area; the second zone was above the first layer of collapsed brick, in this area the depth of the first layer brick was up to 220mm, after callapsing, the upper bricks were unsupported and may have continued to fall, so using the ceramic welding can strengthen this area; the third area was the slightly less damaged or collapse of the first layer of brick. This zone would be the final repair, which had minor effect on the operational performance of the hot stove. The thickness and extent of the spray would be determined accordingly at the time.

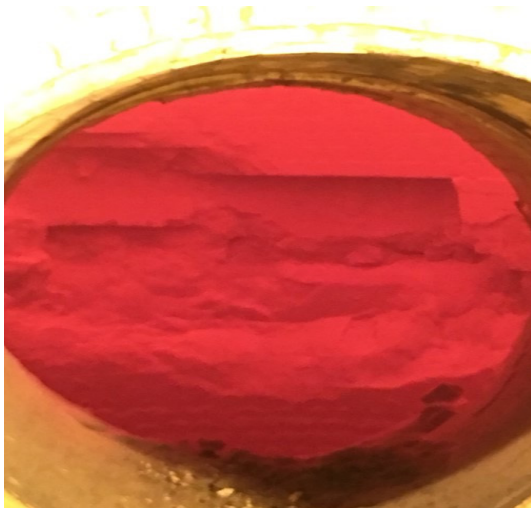
Fig.7. The status of bricks after applying ceramic welding on Dec. 8, 2017

The planned welding time of the ceramic welding was 8 hours, and the actual working time was 7 hours. There were 6 welders and 12 assistants working alternatively. Due to the high heat radiation and unstable hot airflow coming from the hot air outlet main, it was necessary to adjust the suction by opening the exhaust valve of the hot stove. It took about 5-10 minutes for each welder to perform the ceramic welding by taking it in turns. The ceramic material consumed 460 kg in total. The repair team successfully completed the ceramic welding operation after 7 hours. (Figure 7).

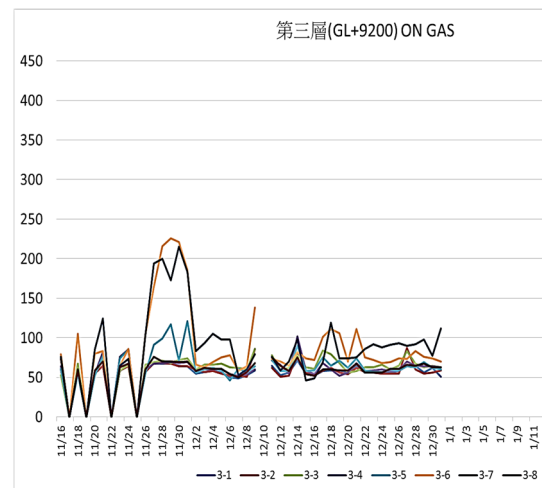
- (2) After the ceramic welding, the iron shell hot spot of No.31 hot stove was kept at 100°C (Fig.8), and the further collapse of the bricks were prevented (Fig.9). It was put back into operation upon the completion of No.3 blast furnace revamping on Feb. 26, 2018 until the shut down for large-scale maintenance in July 2019.
- (3) The ceramic welding repair method was established, and can be listed as one of the repair options for damaged bricks of the hot stove.

Fig.8. The iron shell hot spot decreased to around 100°C after applying ceramic welding.

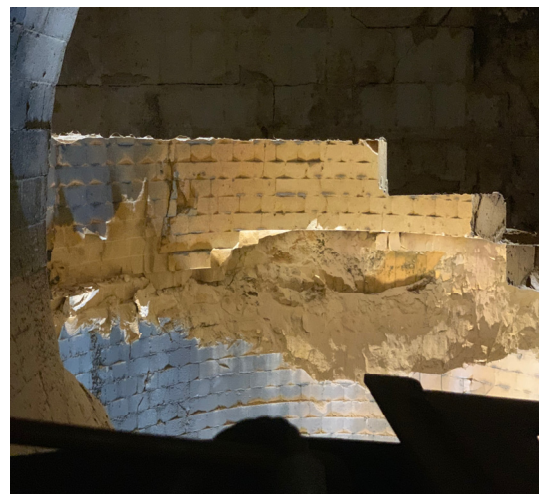
Fig.9. The status of the ceramic welding area after the cooling down of No.31 hot stove on July 5, 2019.
