Investigation and Improvement of Molten Zinc Corrosion of a Sink Roll with Thermal Sprayed WC-Co Coating

*Green Energy & System Integration Research & Development Department,
China Steel Corporation*

Surface treatment for sink rolls in a continuous galvanizing line is an important issue due to the hostile environment of the molten zinc. This study investigated the corrosion behavior of the WC-Co coating in molten zinc. Samples with the WC-Co coating were tested in a zinc pot and were cross-sectioned to examine the microstructure and corrosion morphology. The WC-Co coating defects on a used sink roll were also investigated and compared. The results showed that molten zinc intruded through cracks to attack the substrate which caused major destruction of the WC-Co coating. CSC has developed a special process to solve this problem and has greatly improved the service life of a sink roll.

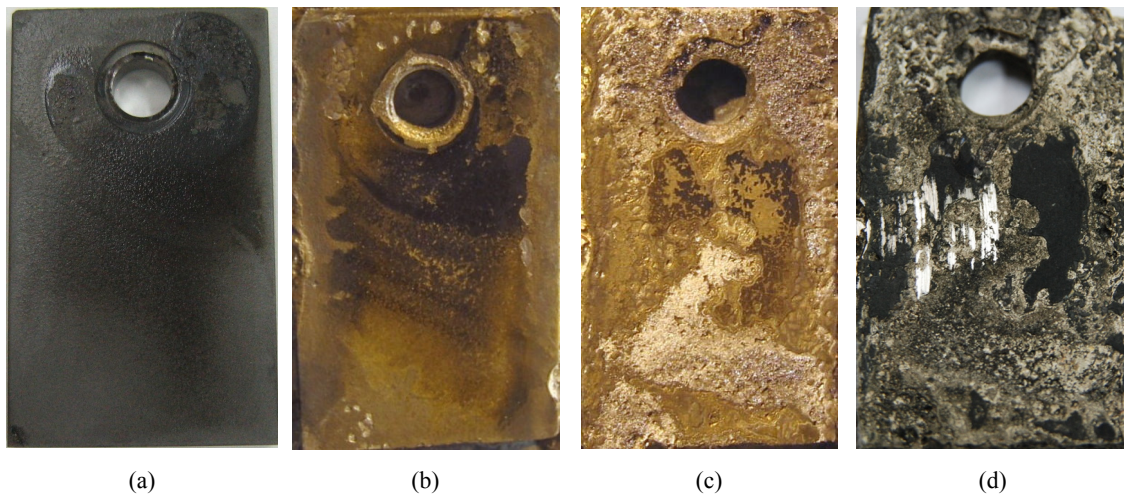
Fig.5. Coating conditions before and after testing. (a) Before testing; (b) After the 1st cycle; (c) After the 2nd cycles; (d) After the 3rd cycles.

first testing cycle, there were minor pits around the sample peripheral. After the second testing cycle, large area spallation was found. When the third testing cycle was done, only about 18% of the coating was remained. Examining the remained coating, it was found that its thickness was almost the same with that of before testing.

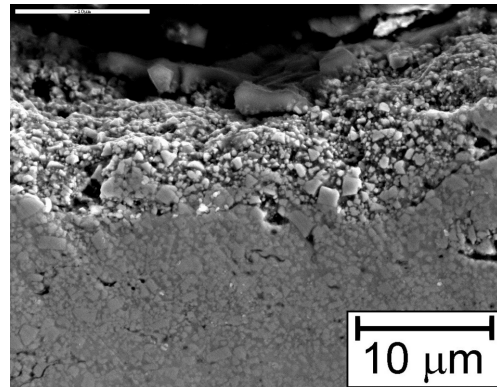
Fig.6 shows the dissolution of Co phase near the coating surface. When the Co phase dissolved into the molten zinc, the WC particles lost the binder and were detached from the coating, resulting in the decrease of the coating thickness. This is the major mechanism reported in the literature⁽¹¹⁾. However, if this is the major reason causing the degradation of the coating, it should be a kind of uniform corrosion. The coating should be thinning uniformly. But it was found that there was still some coating remained unattacked while others had totally gone.

Fig.6. Dissolution of Co phase near the coating surface.

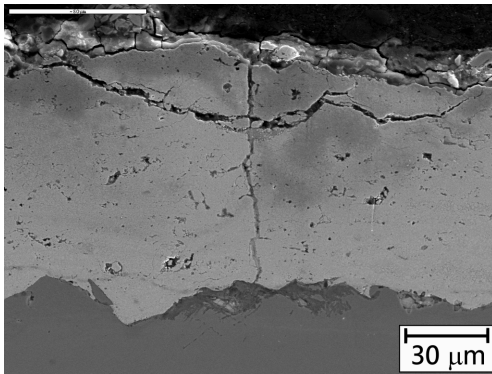
Fig.7 shows the corrosion cracks in the coating. There are both transverse and longitudinal cracks. The longitudinal crack may connect with other longitudinal ones or part of the transverse ones to cause large area decomposition. It is questioned that these cracks might be caused from the sampling preparation. However, there is dissolution of Co phase or diffusion of Zn inside the cracks which indicate that these cracks were formed when immersing in the zinc pot.

Fig.7. Corrosion cracks.

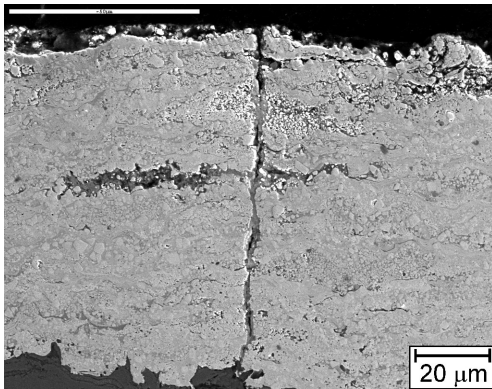
The transverse crack provides a passage for the molten zinc intrusion directly to the substrate. Through the passage, the dissolution of Co phase also occurred inside the coating, as circled in Fig.8. Fig.9 shows one of the transverse cracks and its elemental mapping. From the Co map, the dissolution of Co phase was found inside the coating. From the Zn and Fe maps, zinc was found to intrude the substrate through the crack and caused the dissolution of Fe on the substrate. It is likely to weaken the adhesion strength of the coating.

Fig.8. A transverse crack in the coating.

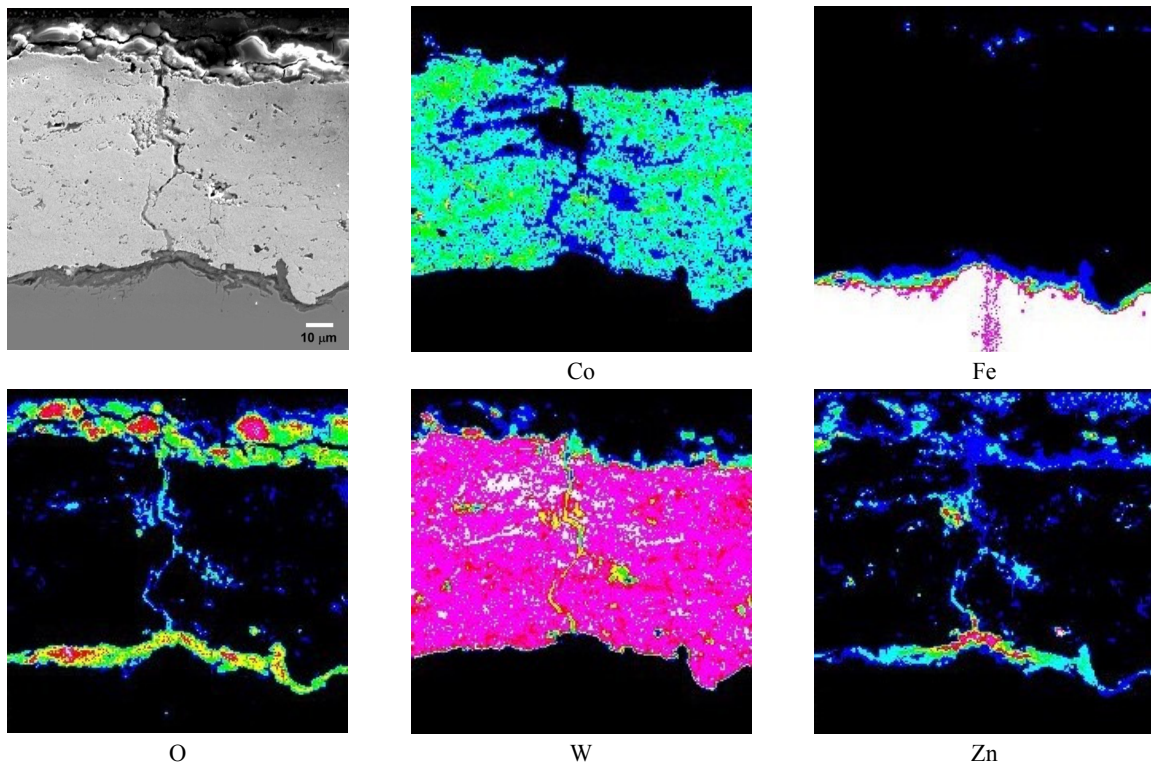
Fig.9. EPMA analysis of a corrosion crack in the coating.

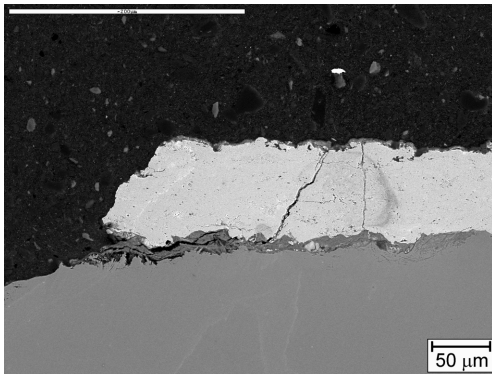
Except through the transverse cracks, the molten zinc was found to attack the substrate from the sample edge or the coating detached area, where the substrate had direct contact with the molten zinc. Fig.10 shows the cross section of the coating. The left side coating was corroded and detached from the substrate. There was significant dissolution of Fe found beneath the remaining coating. Here the dissolution of Fe was most likely by the molten zinc attack from the coating detached area, but not from the transverse cracks. The transverse crack, instead, would connect with the weakened interface and play a role for next large coating area destruction.

Fig.10. Cross section of the coating showing the damage of the coating.

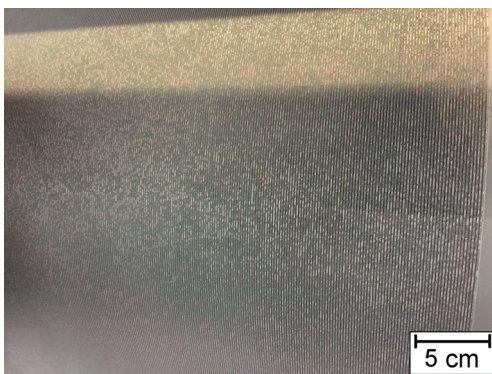
Fig.11 shows a used sink roll with a lot of pits on the roll surface. This roll was thermal sprayed with WC-Co coating although the actual composition of the coating was not known. It has been using in a zinc pot for a few weeks before it was pickled to remove the zinc dross. This kind of pit was also shown on the sample after the first cycle test (Fig.5(b)). Fig.12 is a higher magnification showing the corrosion condition of the coating. It can be seen that this sink roll was sculptured with narrow grooves. The coating was partially corroded. There was coating spallation on selected areas and most of them were on the convex of the grooves.

Fig.11. A corroded sink roll.

With fully understanding of the corrosion mechanism, several attempts have been made to solve the problem. Among them, a special post-treatment after thermal spraying has shown to be highly effective. It helps to seal the cracks and micro-cracks of the thermal sprayed coating, which greatly retards the intrusion of molten zinc. After several on-site tests, the service life of the thermal sprayed sink roll was proven to have been lengthened.

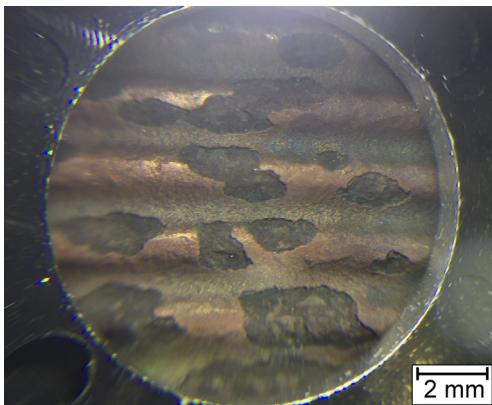
Fig.12. The coating on the grooves has selected area corroded.

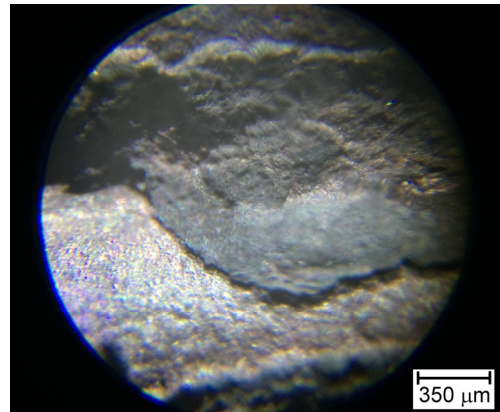
Fig.13 shows the detail of the coating spallation. It seems that the whole coating was missing and revealed the substrate at the corroded area. The uncorroded area kept a certain thickness of the coating. Therefore, it is not uniformly corroded. It is rather selectively corroded by large coating area destruction.

Fig.13. The missing coating reveals the substrate while the remaining coating still has a certain thickness.
