# Failure Analysis of Various Rolling Mill Equipment at China Steel Corp.

*\*Plant Engineering & Maintenance Department*

*\*\* Iron & Steel Research & Development Department  
China Steel Corporation*

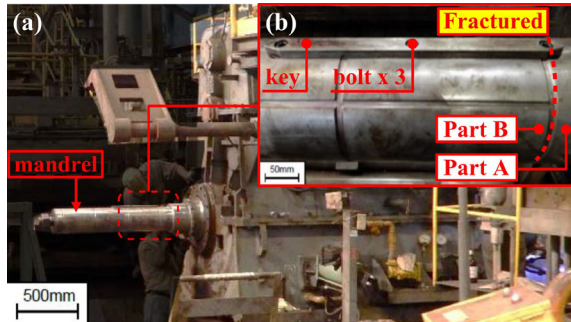
The pay-off reel (Fig.1 (a)), located at the entry section of the strip processing line, unwinds a coil into the downstream line. When the mandrel expands and rotates, the pay-off reel tightens the coil and unwinds the strip to the following equipment. After around 10 years and 7 months of online use, the device cracked at the bolt hole of the key way during normal operation. The broken mandrel was divided into parts A and B for subsequent visual examination. (Fig.1 (b)).

**Fig.1.** (a) the mandrel position of Pay-Off Reel and (b) fractured position of the mandrel.

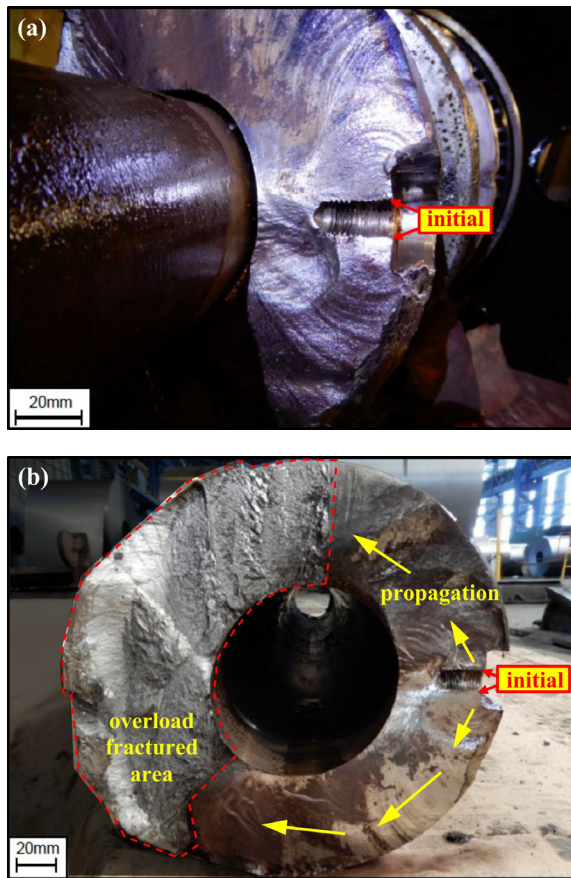
The fractured surface of part A was examined, the characteristic beach mark due to fatigue damage was observed (Fig 2 (a)). It can be used to trace the initial crack at the bolt hole in the keyway. The whole fracture surface analysis of the broken mandrel is shown in Figure 2 (b). Inspection of the bolt hole, the thread of this bolt hole was worn (Fig 3 (a)), and the keyway was wider than the original design dimension (Fig 3 (b)).

**Fig.2.** Fractured surface of mandrel (a) part A and (b) part B.

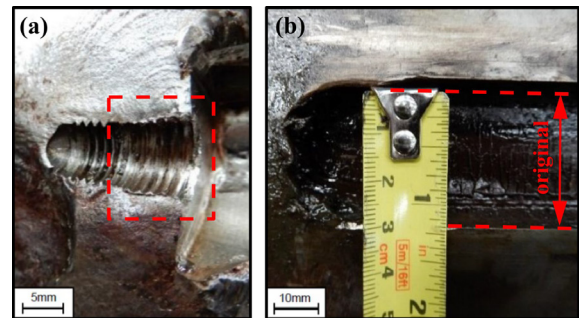
According to this examination, we infer that the mandrel broke as a result of the loosening of the key. The key couldn't be fixed in the keyway since the width of the keyway was wider after long-term service. The force transmission changed from key to bolt due to the above reason and resulted in the bolt hole exerting an abnormal force are shown in Figure 4 (a) and (b).

**Fig.3.** (a) the upper thread of the bolt hole was worn (b) the keyway was wider than the original dimension.

In this case, after determining the cause of the damage, it is recommended that (1) the user should

perform a penetration test (PT) on the keyway and bolt hole when they replace the mandrel parts every three months, to confirm that there is no initial crack caused by abnormal stress at the bolt hole; (2) check the dimension of the keyway and bolt hole to avoid the same failure occurrence; (3) change the design of the mandrel, including the position of the broken bolt hole to reduce stress concentration, and by adding a second keyway on the opposite side of the existing keyway, so that when the keyway is worn beyond tolerance, the second keyway can be used to extended the service life.

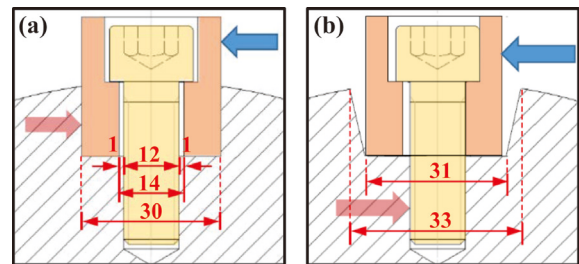
**Fig.4.** Torque transited (a) by key and (b) by the bo.

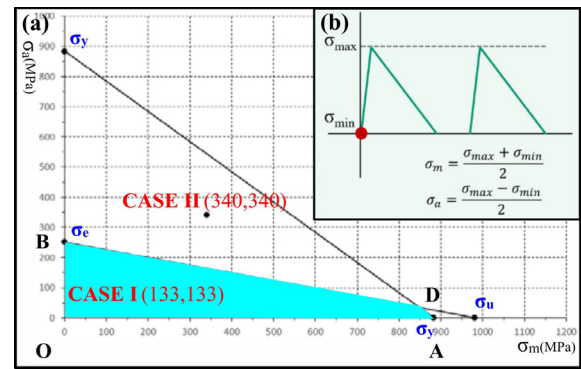
In order to verify the inference, we used the finite element analysis software MSC.MARC to create models to simulate the load cases of Figure 4 (a) and (b) respectively, and the results are shown in Figure 5 (a) and (b). In Case I, the maximum equivalent von Mises stress ( $\sigma_{VMS}$ ) is located at the fillet of the mandrel, not at the fractured bolt hole. The maximum  $\sigma_{VMS}$  at the bolt hole is 266 MPa, which does not exceed the fatigue safety limit region (OADB) of the mandrel material (SNCM439) drawn by the Goodman diagram method (Fig.6 (a)), so that fatigue damage does not occur. In Case II, the maximum  $\sigma_{VMS}$  is located at the fractured bolt hole, and its value of 680 MPa exceeds the fatigue safety limit region (OADB) and fatigue damage will occur. Therefore, Case II is the same as the inference of visual examination.

Fig.6. (a) Goodman Diagram<sup>(4)</sup> and (b) the loading curve of the mandrel.

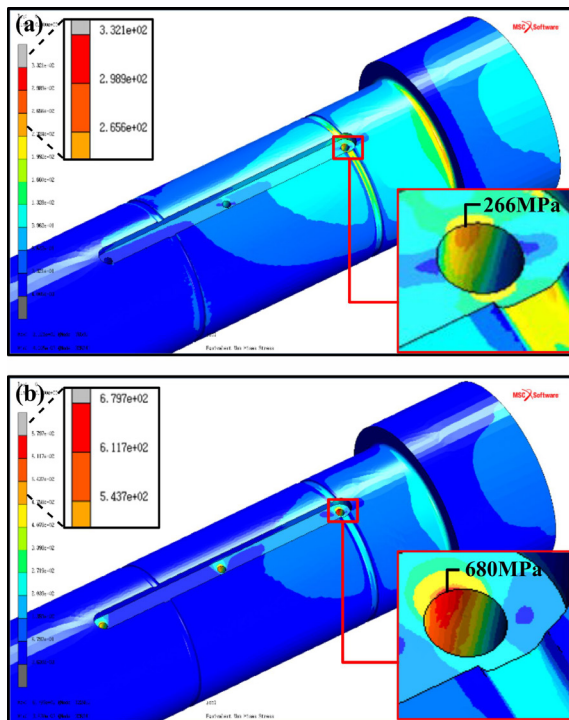
Fig.5. Stress concentration on (a) Case I and (b) Case II.

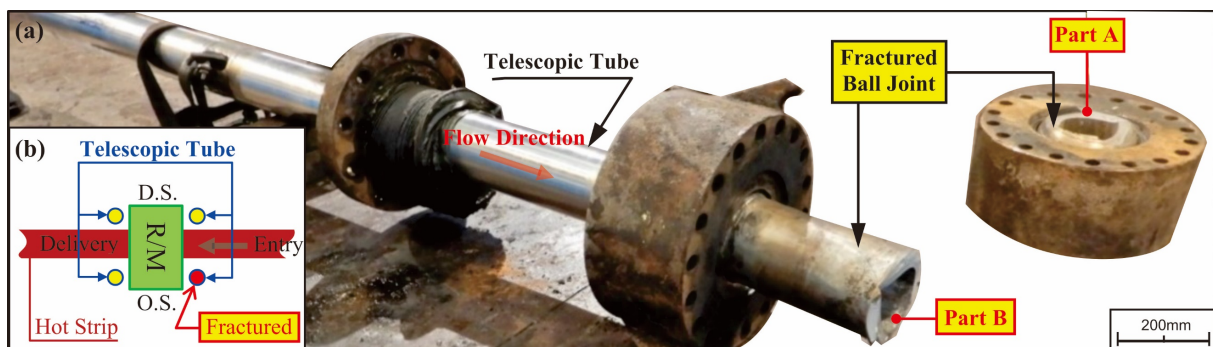
The telescopic tube with ball joint (Fig.7 (a)) of the descaling system is used to transfer the 220-bar of high-pressure water to the downstream nozzles to remove the scale on the hot strip to maintain the high-quality of the strip products. There are four telescopic tubes vertically mounted on the rolling mill, the strip entry and delivery side have two each respectively as shown in Figure 7 (b). One day, the descaling system was alerted to a pressure drop and staff found that the ball joint of the rolling mill entry, operator side was cracked and was ejecting the high-pressure water. After disconnecting the ball joint, it had divided into two pieces (part A and B) as shown in Figure 7 (a). Besides parts A and B, there are two longitude cracks (crack #1 and crack #2) on the ball joint and divide part B into B-1 and B-2, as shown in Figure 8 (a) and (b).

Fig.7. (a) Telescope tube with ball joint and (b) the location of the fractured ball joint.

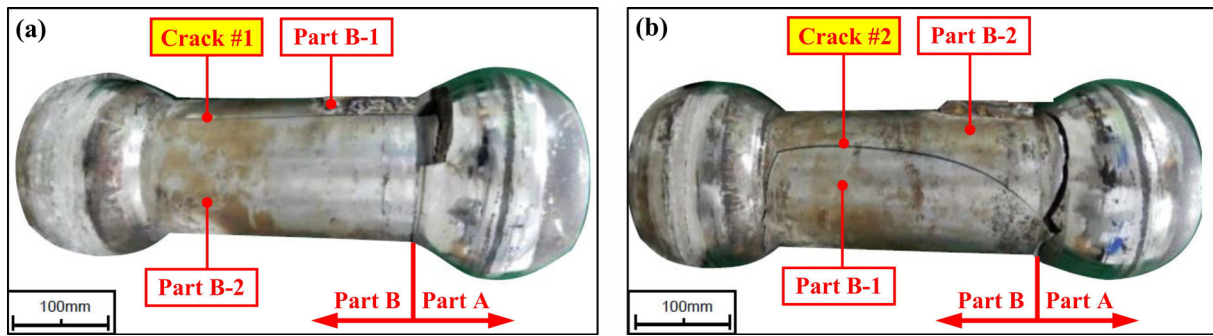
Fig.8. Different views of the fractured ball joint (a) viewpoint 1 and (b) viewpoint 2.

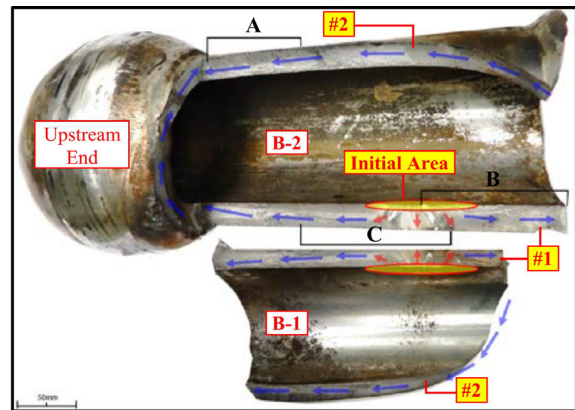
Figure 10 shows the complete crack propagation analysis of parts B-1 and B-2, the fractured characteristics of A, B, and C areas are shown in Figure 11 (a), (b) and (c) respectively. Combine with the analysis of Figure 9 (d), it can be judged that the fractured ball was initially started at the red ellipse mark of crack #1 in Figure 10, and then propagated toward the upstream and downstream end. In the downstream end, the crack is divided into two directions as shown in Figure 9 (d), the left-hand crack developed earlier and formed crack #2 of parts B-1 and B-2, and the right-hand crack was finally intersected at crack #2.

Fig.10. The crack propagation of part B-1 and B-2

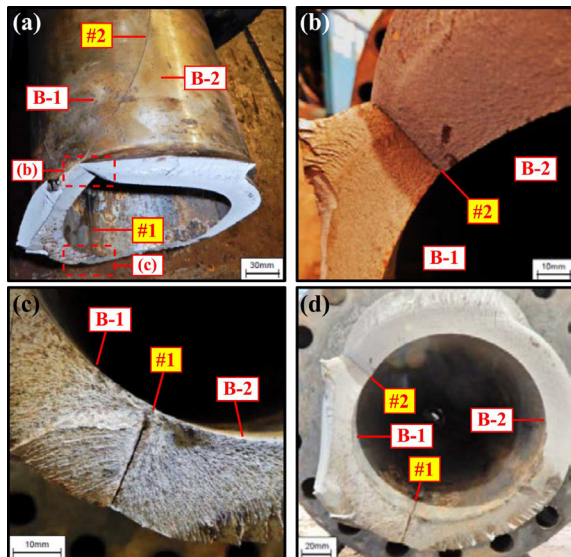
Inspecting part B (Fig.9 (a)), it was judged that the left cracked surface (B-1) of part B developed earlier than the right-hand cracked surface (B-2) according to the T-shaped crack generation principle. Figure 9 (b) and (c) zoomed in area of the red framed areas in Figure 9

(a); they can be judged as the crack intersection and initial crack of part B’s fractured surface respectively, by radial marks. The complete crack propagation of part B’s fractured surface is shown in Figure 9 (d).

Fig.9. Part B (a) zoomed out view, (b) zoomed in view of the crack intersection, (c) zoom in view of the initial crack, and (d) complete crack propagation.

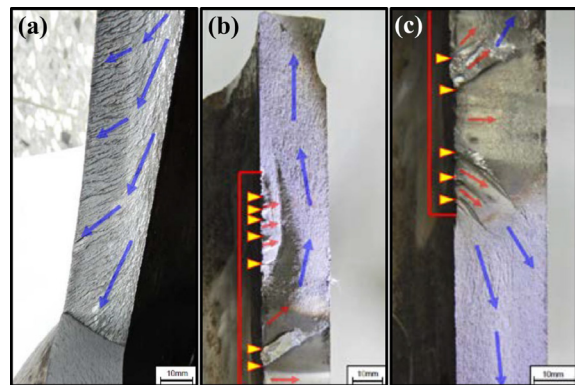
Fig.11. Part B-2 (a) area A, (b) area B, and (c) area C.

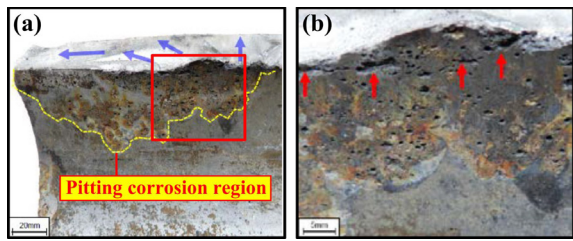
The characteristics of pitting corrosion as shown in Figure 12 (a) were found at the inner surface of crack #1 initial area through further inspection. Figure 12 (b) shows the zoomed in red framed area of Figure 12 (a); it showed that the pits near the initial area were connected to form the cracking seams, and the direction of the cracking seams is consistent with the direction of the cracks caused by the pressure.

**Fig.12.** (a) the inner surface of part B-2 initial area and (b) pits form the cracking seam.

According to these findings, we speculated that the pitting corrosion at the inner surface was the root cause of the fractured ball joint. The pits formed the cracking seams under the repeating pressure change while downstream nozzles opened and closed, and then the cracks propagation resulted in eventual fractured.

According to the above analysis and inference, it is recommended (1) prior to use, check if there is any abnormal hole or defect on the inner surface of the ball joint and remove all residuals on the inner surface, such as anti-rust oil, deposits, and rust, to avoid the existence of stress concentration or undesirable factors that cause chloride ion aggregation. (2) During storage, seal the ball joint tightly and store it in a nearly vertical manner to avoid induced corrosion caused by the external environment.

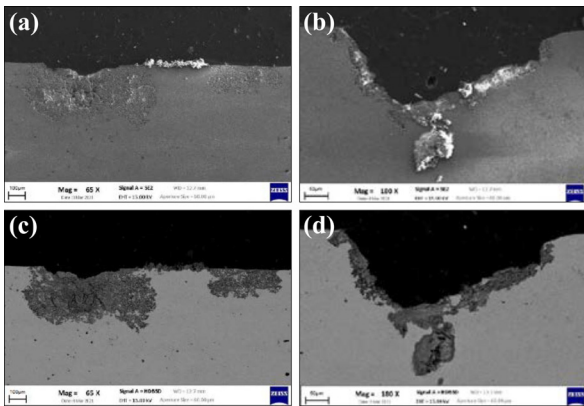
To verify the inferences, different micro-holes of corrosion regions were first observed by SEM and BSE as shown in Figure 13 (a) to (d). It can be clearly observed that the eroded part of the micro-holes is different in color from the original material, which means that the microstructure of the local area had changed to be very different from that of the original material.

**Fig.13.** The SEM and BSE image results of two different pitting positions. (a) position 1 SEM, (b) position 2 SEM, (c) position 1 BSE, and (d) position 2 BSE.

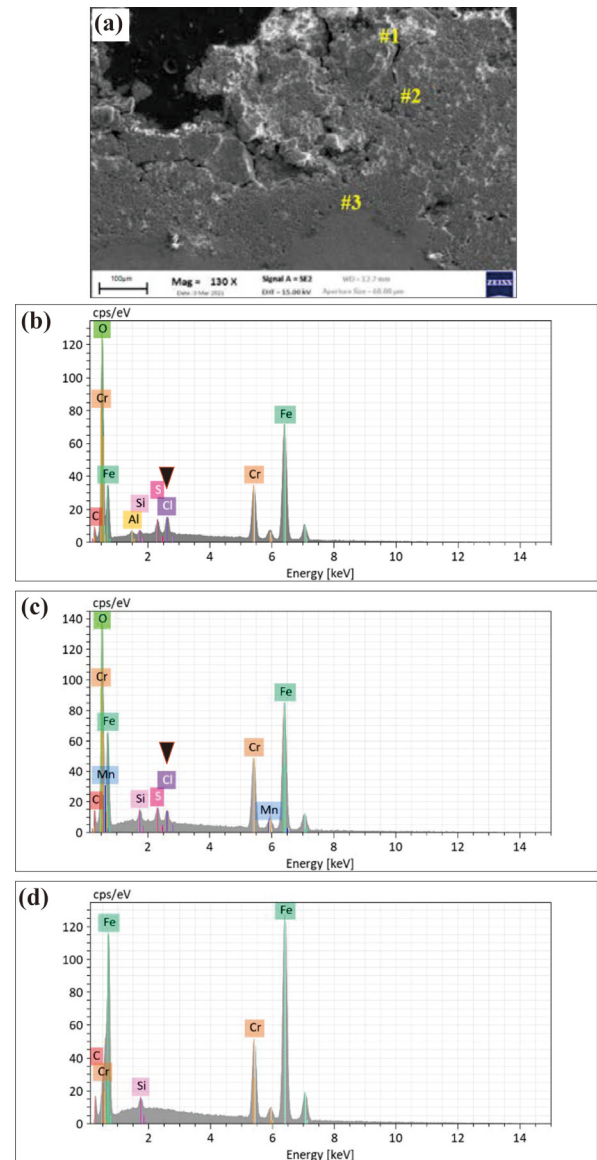
The micro composition of different micro-holes of corroded regions were checked by EDS, Figure 14 (a) shows the corrosive element Cl was found at the eroded positions #1 and #2 and wasn't found at the original material position #3. The detailed composition of each position is shown in figure 14 (b) to (d), and it can be confirmed that the micro-holes of corrosion were induced by the element Cl. It is typical pitting corrosion consistent with inference.

**Fig.14.** (a) Three testing position at pits and the EDS results for each position. (b) position 1, (c) position 2, and (d) position 3.

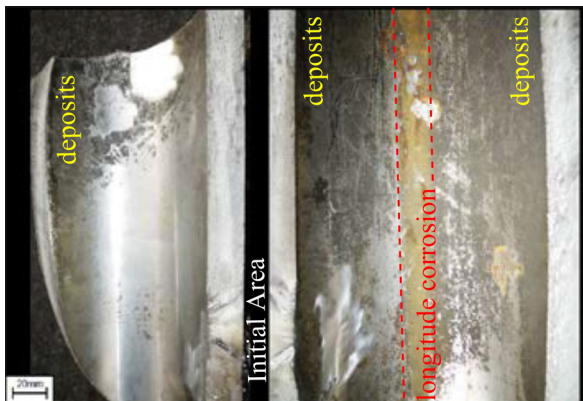
In this case, it was further confirmed that the composition of the descaling water, especially the corrosive element Cl, was within the control range of the water treatment plant. The ball joint was equipped vertically on the rolling mill, but a longitude corrosion region and deposits were found on the inner surface as shown in Figure 15, which means that the ball joint had corroded when it was placed in a horizontal manner. Since the above finding and the other ball joints didn't rupture. It is speculated that the fractured ball joint was an independent case, it had been polluted before online use

resulting in a local flow field changing occurrence and chloride ion aggregating further.

**Fig.15.** A longitude corrosion region on the inner surface.
