Premature Failure Analysis of Mill Rolls at China Steel Corp.

*Plant Engineering & Maintenance Department
China Steel Corporation*

The premature failure of mill rolls can be costly not only due to its high initial cost but also the huge cost of rolling mill downtime. In this paper, a backup roll with a fractured roll neck in a temper and recoil line is investigated. To identify possible root causes, loading patterns of the rolling process, detailed fracture characteristics, and propagation direction of the premature fractured roll were inspected, while a high-stress spot at the roll neck during the normal rolling process was evaluated by the finite element method (FEM). The results revealed that such premature failure was unlikely to be caused by stress behavior under normal rolling, but corrosion pitting pits clustered around the roll neck surface could induce high-stress concentration under such circumstances and facilitate overloading damage. In addition, the corrosive element intruded upon the roll neck surface due to the crevice corrosion between the backup roll and the press-fitted thrust ring was strongly in doubt. The corrosion effect seemed to be accelerated by some obvi

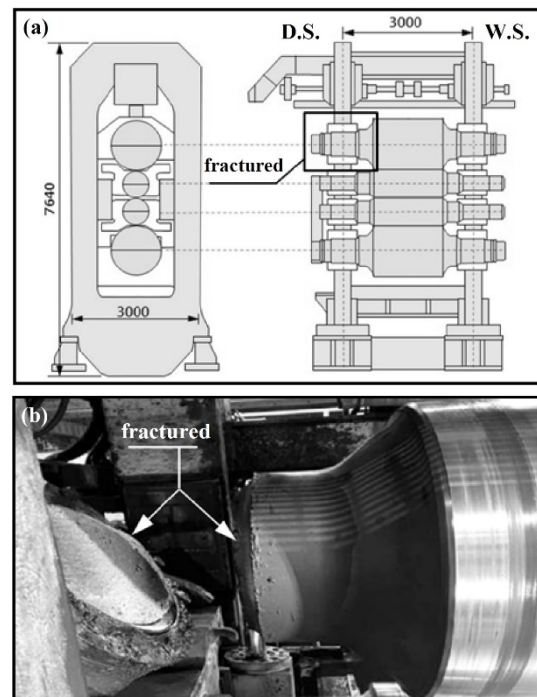
The 4-Hi rolling mill of a Temper and Recoil Line (TNRL) is commonly used to handle hot-rolled coil. It can improve the shape and mechanical properties of the strip. The top backup roll of the 4-Hi mill broke around the drive-side (D.S.) roll neck during normal operation at a TNRL of the CSC group. This had never happened before and caused significant productivity loss in the mill. To avoid similar accidents reoccurring and prevent the consequent issues at other mills, it is necessary to identify the main problem in this event and make improvements immediately. Figures 1 (a) and (b) show the location and actual situation of the broken roll, respectively.

Fig.1. The location (a) and the appearance (b) of the broken roll.

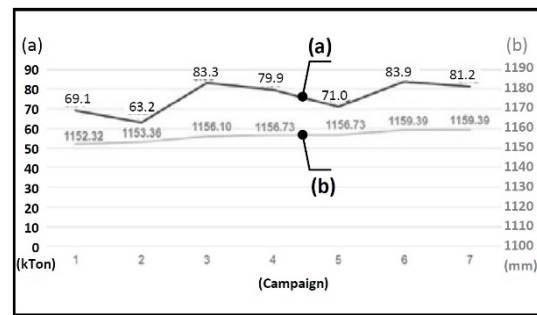
Figure 2 shows the rolling and grinding history over the last 7 campaigns. The average monthly rolling tons in this campaign wasn't the highest, and the trend of diameter variation revealed no over-grinding from rolling accidents.

Fig.2. (a) The average monthly rolling tons of each campaign and (b) the decreasing trend of grinding diameter.

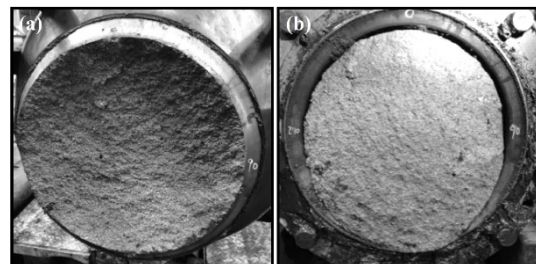
The fractured backup roll was separated into two parts. Part A was designated for the larger piece and Part B was the smaller piece. Their fracture surfaces were not like any visually identifiable arrest marks, such as ratchet marks, beach marks, radial marks, or chevron marks^[2] as shown in Figures 3 (a) and (b). The fracture propagation direction could not be determined and hence we can't find the initial point to infer the root cause.

Fig.3. Fracture surface of (a) Part A and (b) Part B.

Using the fractography atlas is another way to determine the root cause. By comparing Figures 3 (a) and (b) to the fractography atlas of the ASM Handbook (Fig.4) and the CSC’s roll failure database (Fig. 5), the premature failure possibility of the backup roll from rotating bending fatigue or internal manufacturing defects could be excluded.

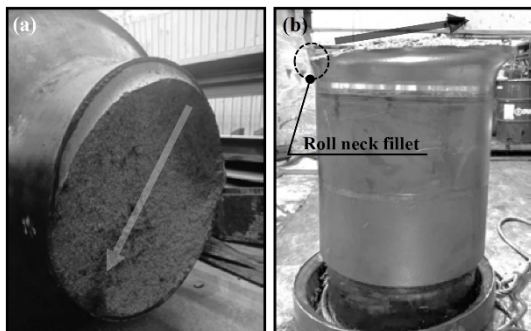
Figures 6 (a) and (b) show the appearance of Part A and Part B. The fracture surface is plain and presents a single angle with a roll axis. In Figure 6 (b), the side of the fracture is at the roll neck fillet and the other at the larger diameter. Based on finite element analysis (FEA) experience, the maximum stress located at the roll neck fillet is more possible than at the bigger diameter. It is speculated that the fracture surface started at the roll neck fillet and ended at the bigger diameter, as the arrows shown in Figures 6 (a) and (b).

Fig.6. Fracture appearance of (a) Part A and (b) Part B.

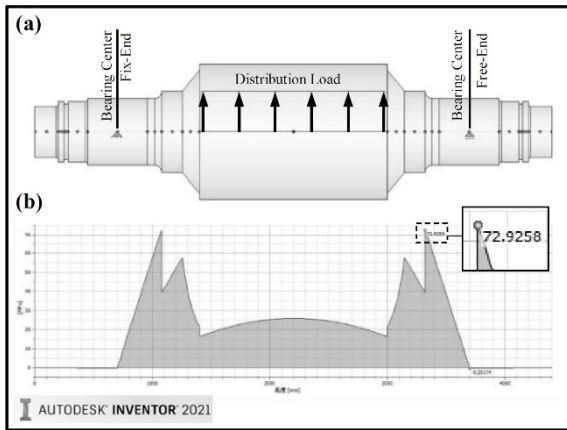
The fracture appearance shows that the loading mode of roll failure isn’t fatigue but overload. To evaluate the stress of the roll, mechanical design software (Autodesk Inventor) and finite element analysis software (MSC Marc) are used. Figure 8 (a) shows the free-body diagram of the backup roll during rolling. The distribution load equals roll force divided by the contacting length with the work roll, while the center line of the fix-end bearing and free-end bearing are pin support and roller support respectively. The result calculated by Autodesk Inventor shows that the maximum stress is located on the fillet of the roll neck. It matches the speculation in the previous visual examination, but the maximum stress is only 73 MPa, it didn’t exceed the tensile strength (430~485 MPa) of the roll material.

Fig.8. The stress calculated by Autodesk Inventor (a) model and (b) results.

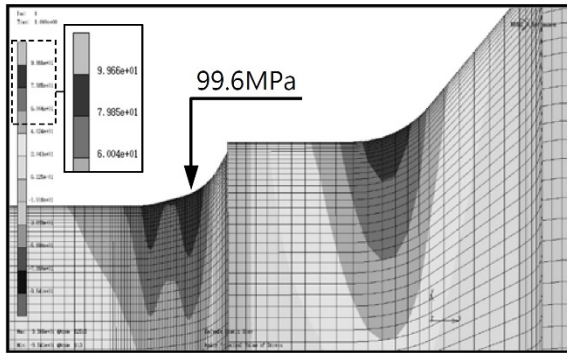
An MSC MARC fine-mesh model was created to re-evaluate the stress of the fillet. The analysis results show that the maximum stress is also located at the fillet, but the value less than 100 MPa still didn’t exceed the tensile strength, as shown in Figure 9.

Fig.9. The FEM result of the fillet of the top BUR.

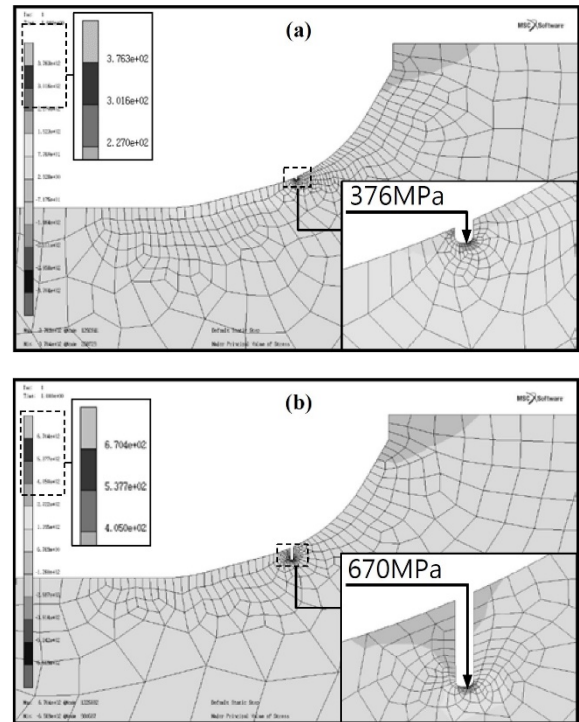
Figures 10 (a) and (b) show the simulation results of different artificial defects at the roll neck fillet.

If there is a 1mm wide and 1mm deep artificial defect in the whole circumference of the roll neck fillet, under the same load and boundary condition, the stress of the fillet will increase approximately 3.7 times (from 99.6Mpa to 376Mpa) as shown in Figure 10 (a). The stress will exceed the tensile strength (430~485 MPa) of the roll material while the depth of the artificial defect is over 5mm as shown in Figure 10 (b). These results mean the smooth propagation area of the fractured surface can only be observed within 5mm, and explain why the fractured surface was almost all rough and fast-breaking.

Fig.10. The FEM results of the backup roll with artificial defect, (a) width 1 mm/depth 1mm and (b) width 1 mm/depth 5mm

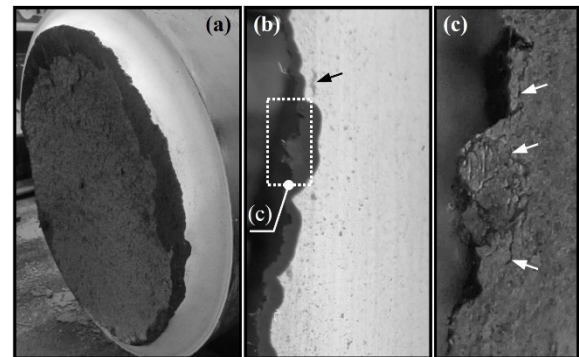
Figure 11(a) shows the PT results of the roll neck surface of Part A. The defects like cracks and micro-holes scattered around the roll neck surface were found as shown in Figure 11(b) and some cracks even connected to the fracture surface as shown in Figure 11 (c).

Fig.11. PT result of part A, (a) appearance, (b) cracks and micro-holes, and (c) defects near fracture surface.

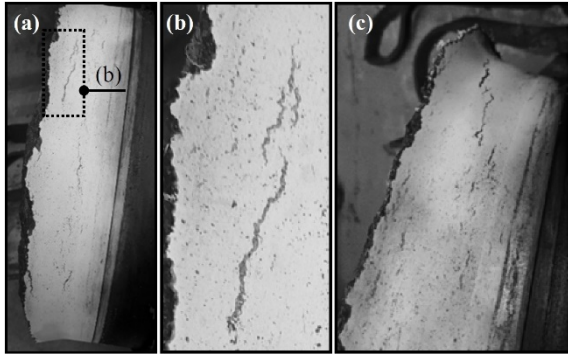
Figure 12 (a) shows the PT results of the roll neck surface of Part B. Compared to Part A, the cracks and micro-holes at Part B can be found more easily and have more as shown in Figure 12 (b) and (c).

The cracks detected by PT at Parts A and B are all developed in the circumferential direction. Those are perpendicular to the principal stress direction subjected

to the roll force and have many micro-holes within or near the crack as shown in Figure 12 (b). It can be judged that these cracks were all induced by micro-holes while being subjected to roll force.

Fig.12. PT result of part B, (a) appearance, (b) cracks and micro-holes, and (c) defects at different locations.

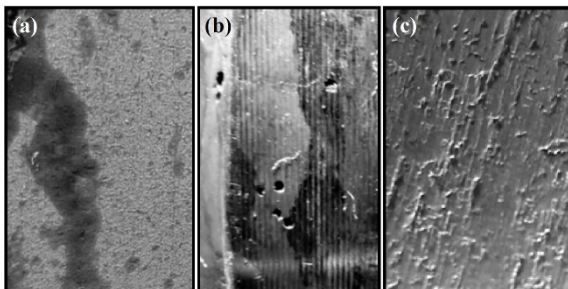
The micro-holes were found around the whole circumference of the roll neck fillet. Zoomed in to observe the feature of the micro-holes, Figure 13 (a) near the fracture surface as an example, the boundary of the holes are irregular, without obvious burrs and scratches, which are different from the hole characteristics of casting porosity (Fig. 13 (b)) or invasion wear (Fig. 13 (c)). Its characteristics should belong to the pitting caused by corrosion.

Fig.13. (a) The micro-holes around the roll neck, (b) Casting porosity, and (c) Abrasive wear.

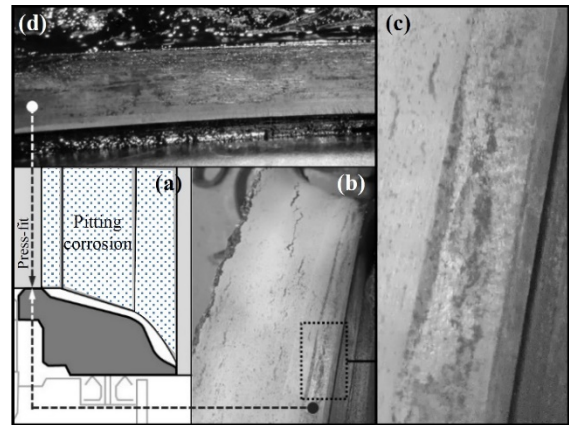
Re-observed these pitting corrosions are mainly scattered within the area covered by the thrust ring, as shown in Figure 14 (a), which is one side press-fit on the backup roll shaft and the other side in close contact with the barrel end. The corrosion that occurred on the thrust ring press-fit region of the backup roll is more serious than the other surface, as shown in Figures 14 (b) and (c), and there is similar damage at the contact surface of the thrust ring (Fig. 14 (d)). It seems the presence of narrow gaps between the backup roll and the thrust ring gives rise to localized corrosion at these sites. These features match with crevice corrosion.

Fig.14. The pitting corrosion scattered region (a) and the crevice corrosion at the press-fit of the thrust ring (b) and the backup roll (c) (d).

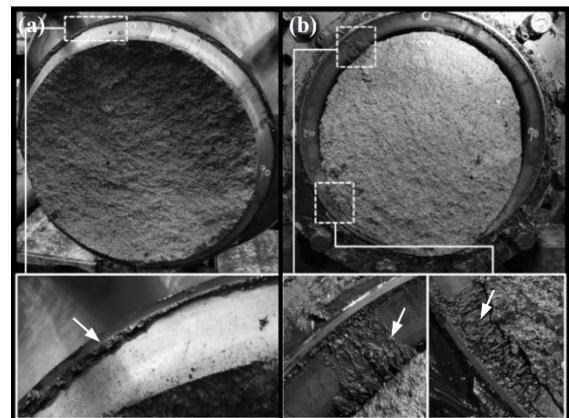
Considering the above mechanism of crevice corrosion and the operating environment of this TNRL, it doesn't use cooling water or rolling oil during rolling, and the space between the thrust ring and backup roll is without any filling solution, it is inferred that the crevice corrosion between the thrust ring and the backup roll may have been caused by residues covering the gap in the past. Hence, there were residues on the thrust ring and its relative space of the backup roll as shown in Figure 15, which resulted in oxygen differential cells occurring in the local area. In addition, the corrosion was more served on the rough tooling marks region than on the fine region as shown in Figure 16.

Fig.15. The residues at the thrust ring installation area of Part A (a) and Part B (b)

Removing residues stuck in the gap after every campaign and upgrading the roughness of the fillet surface is recommended. It could effectively inhibit the corrosion development and might decelerate the crack propagation on the roll neck and prevent and/or terminate such roll failure in time to extend the life of mill rolls.

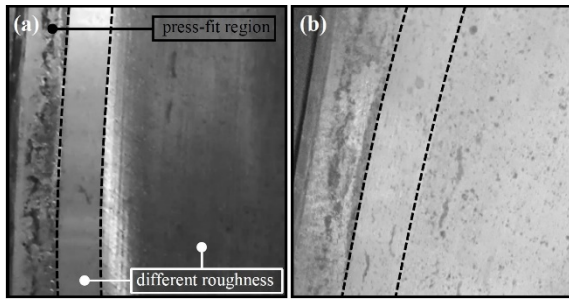
Fig.16. The corrosion at different roughness (a) VT results and (b) PT results.
