Experience of Salamander Tapping for Blast Furnace Relining in CSC

*Iron & Steel Research & Development Department
China Steel Corporation*

The salamander tapping experience before the relining of two blast furnaces in CSC (China Steel Corporation) is described in this paper. In 2013, the total liquid metal received from the salamander tapping of No.4 BF was about 1150 tons and no dynamiting operation was done for the residual metal block in the hearth. In 2017, at No.3 BF, the total liquid received from the salamander tapping was about 168 tons. And, about 634 tons of the residual solid block was cut into 43 pieces by the wire cutting machine. Based on the experience, suggestions for successful salamander tapping are summarized as follows: First, the temperature monitoring for the carbon brick of the hearth is indispensable for estimating the profiles of the solidified line and the erosion line. Secondly, an appropriate operation strategy for maximizing the ratio between the liquid and the solid salamander is to make the productivity of the blast furnace as close to the highest productivity on record. It is inferred that when the temperature before relining is near the historica

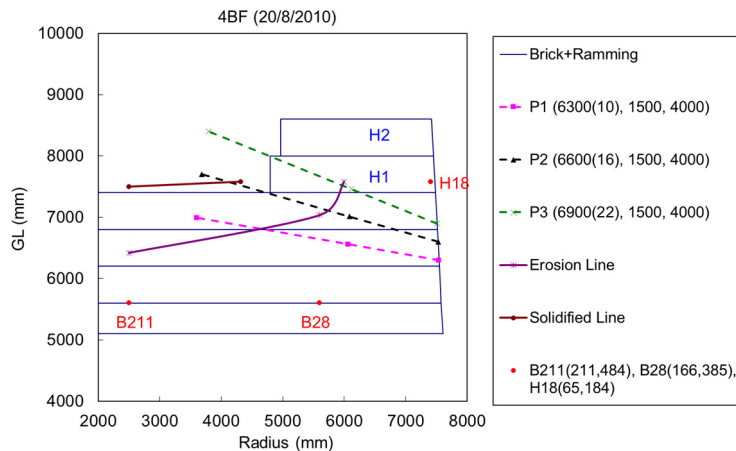
Fig.1. A hearth status with solidified line and erosion line and presumed core drilling paths

The design campaign life of CSC No.4 BF with a hearth diameter of 12.5m is 15 years. It came into operation in November, 1996. In order to understand the hearth status, the historical maximum temperature of carbon bricks was adopted to estimate the wear erosion of the hearth on 20 August, 2010. Figure 1 presents a hearth status with the solidified line of the salamander and the erosion line of carbon bricks. The daily average temperature on 20 August, 2010 and the historical maximum temperature at B211 measuring point were 211°C and 484°C, respectively. There are 4 layers of carbon brick at the bottom of the furnace, and the top 2 layers were eroded. Therefore, the elevation of salamander tapping was suggested to be close to the erosion elevation. Three presumed paths of the core drilling for the salamander tapping with 300 mm gap in elevation between holes are represented by three dotted lines in Figure 1. The elevation and angle of P1 hole was 6300mm above ground level and 10 degrees, respectively. The presumed depths of core drilling and oxygen lancing were 1500 mm and 4000mm, respectively.

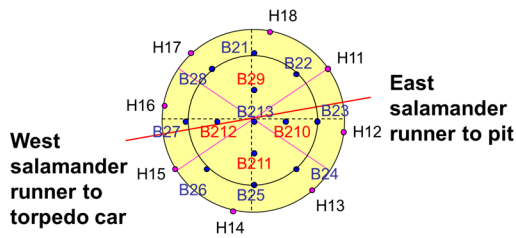
Fig.2. Position of thermocouples for measuring the temperature of hearth bricks in No.4 BF

Two positions for salamander tapping were adopted in the successful experience of the salamander tapping. There were two salamander runners, one for charging into the torpedo car, and the other into the pit. Figure 2 shows the position of thermocouples for measuring temperature of the hearth bricks of No.4 BF. The measured temperatures at positions near the salamander tap were used to estimate the solidified line of salamander and the erosion line of bricks.

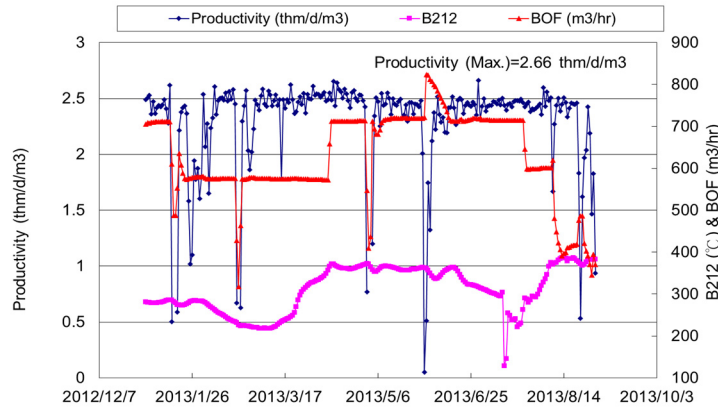
Fig.3. Productivity, bottom temperature and water flow rate before No.4 BF relining

order to increase the ratio of liquid to solid salamander, the higher productivity of above 2.3 thm/d/m³ and the lower cooling water flow rate at the bottom of the BF were pursued in the BF operation. Figure 3 shows the variation of productivity, hearth bottom temperature and cooling water flow rate before No.4 BF relining. On 13 August, 2013, the measured temperature of 376°C at B212 is close to the historical maximum temperature of 416°C and listed in Table 2.

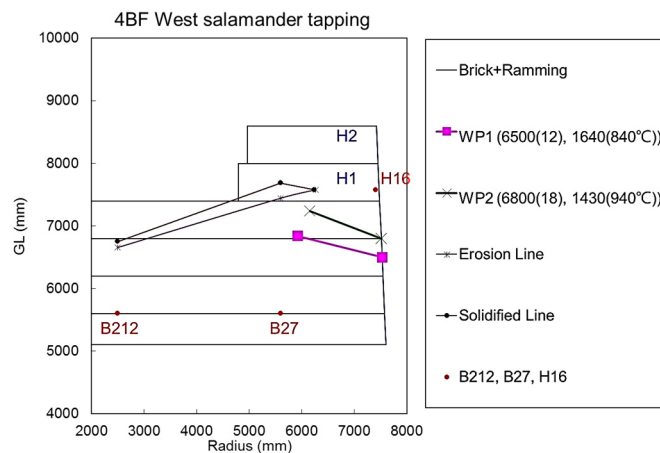
Fig.4. The salamander tapping operation at the west of No.4 BF

Based on the solidified line, the erosion line and previous experience, two salamander tapping paths with 300mm gap in elevation at the ramming mix were decided for the salamander tapping at the west of the BF as shown in Figure 4. The elevation and angle of the

WP1 hole was 6500 mm above ground level and 12 degrees, respectively. The interim temperature measurement during the drilling process should be made for preventing liquid salamander suddenly flowing out from furnace. For safety, the core drilling was stopped when the depth of core drilling was 1640 mm when the measured temperature at the drilling forward end reached 840°C. After the completion of WP1 hole drilling, the WP2 hole was done at 6800 mm above ground level and with an angle of 18 degrees.

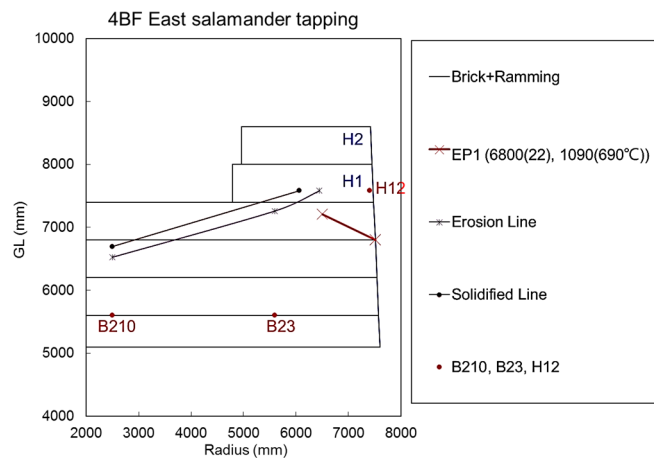
Fig.5. The salamander tapping operation at the east of No.4 BF

In the meantime, EP1 hole drilling was done at 6800 mm above ground level with an angle of 22 degrees at the east of the BF. The position of EP1 hole was higher than that of WP1 hole because the liquid salamander flowed through EP1 hole into the pit. The depth of core drilling and temperature were 1090 mm and 690°C, respectively.

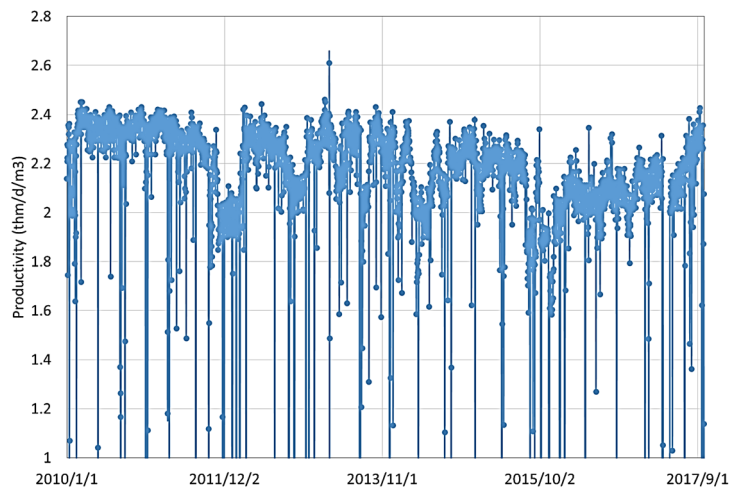
Fig.6. Variation of productivity from 2010 to relining at No.3 BF

Based on the evaluation results of the shaft and hearth status, the second relining of No.3 BF was scheduled on 30 September, 2017. Figure 6 shows the variation of HM (hot metal) productivity of No.3 BF operation from 2010 to the date of blowing down for the relining. It also shows that the normal productivity was

around 2.4 thm/d/m³ in 2010. Due to the hot stove problem that occurred in 2016, the productivity decreased to and remained under 2.2 thm/d/m³. Although the productivity increased to 2.3 thm/d/m³ on 24 September, 2017, the measured temperature of B42 was 284.4°C, much lower than the historical maximum temperature of 904 °C (listed in Table 3). The large difference between these two temperatures means that there was a large amount of solid skull left in the hearth.

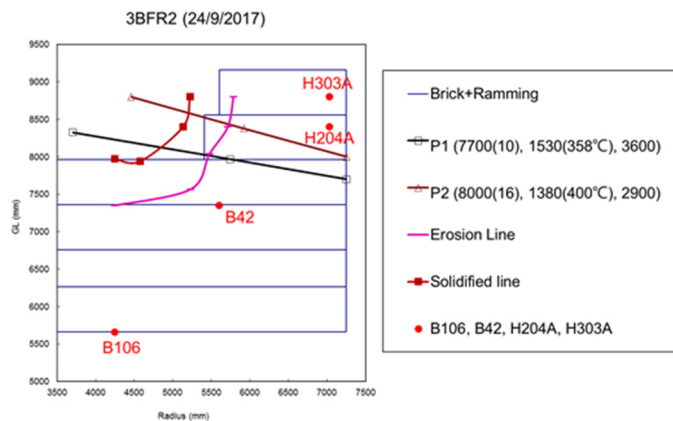
Fig.7. The salamander tapping operation at No.3 BF

Single position for the salamander tapping operation was adopted due to the restriction of soft water supply. Figure 7 shows the solidified line, the erosion line and two drilling paths in the hearth of No.3 BF. The elevation and the angle of P1 hole was 7700 mm above ground level at 10 degrees, respectively. Due to the difficulty to drill deeper, the core drilling was stopped at a

path depth of 1530 mm and a temperature of 358°C at the drilling face. After completion of drilling P1 hole, P2 hole was drilled at 8000mm above ground level and with an angle of 16 degrees. On consideration of the thicker solidified layer, the positions of these two holes were set higher than that of the holes at No. 4 BF.

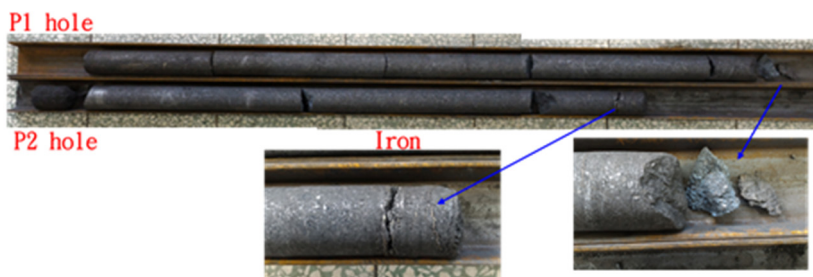
Fig.8. Samples taken from the core drilling of P1 hole and P2 hole

Figure 8 shows photos of samples taken from the core drilling of P1 hole and P2 hole. It was noted that a segment of iron was found at the drilling end of each sample. Based on the lengths of carbon brick and iron segment, it was proven that the erosion line estimated by CSC is reliable enough for the salamander tapping operation.

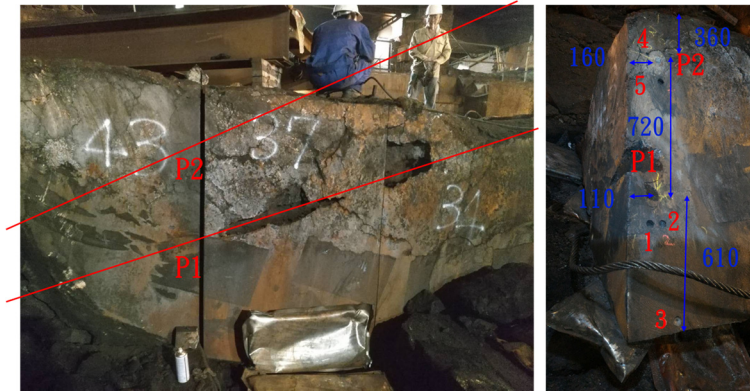
Fig.9. Investigation of the salamander tapping paths at No.3 BF

In CSC, this was the first experience of using the wire cutting machine for breaking a large solid salamander left in the hearth as to avoid the danger and pollution from a dynamiting operation. Figure 9 shows the investigation of the salamander tapping paths of P1 and P2 holes on the wire-cut solid salamander from No.3 BF. In Figure 9, it was clearly observed that the pathway of P1 hole was empty and that of P2 hole was full with slag with the composition listed in Table 4, labelled as sample no. 4. In order to investigate the compositions of the large salamander, five samples were collected at salamander 43 as shown on the right side of figure 9. The result of SEM-EDX analysis on these samples are listed in Table 4. Based on the chemical compositions, it is distinguishable that sample 1 is carbon brick, sample 2, 3,
