Development of Precision Rolling Process Technology in Coil Bar and Rod

* Metallurgical Department
 ** Iron and Steel R&D Department
 *** Rolling Mill Department I
 China Steel Corporation

Keywords: Fastener Industry, Wrinkle, Seam Free, Cold Heading

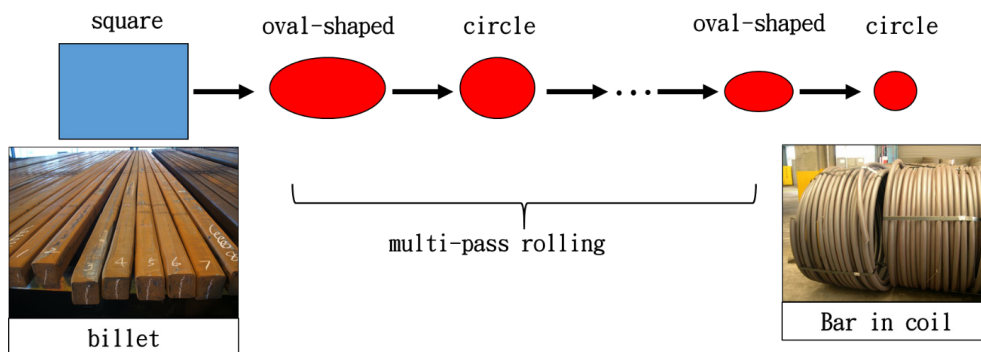
Fig.1. Process of billet rolling to coil.

In the production process of the bar in coil, the heated billet will go through a sequence of multi-pass rolling. There, the original square billet is gradually reduced and formed into the desired circular shape, as shown in Figure 1. Most of the products used for cold-heading are screws and nuts, and almost 100% of the entire coil is fully used. Consequently, when a coil extends as long as several kilometers with partial seam defects, cracks may occur during the following cold-

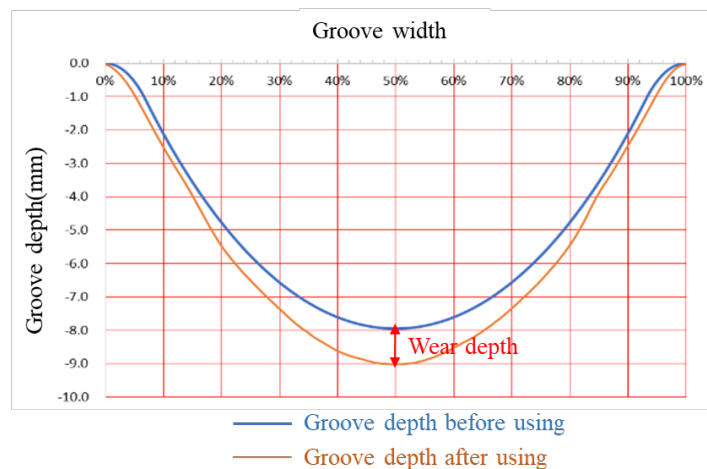
Fig.11. Roll groove profile scanned by laser rangefinder.

To confirm the relationship between rolling count and cumulative wear factor with the actual wear depth of the roll groove, we arranged actual measurements to verify the applicability of the wear factor. Using a laser rangefinder to scan and draw a cross-sectional profile, as shown in Figure 11, which represents the deepest wear

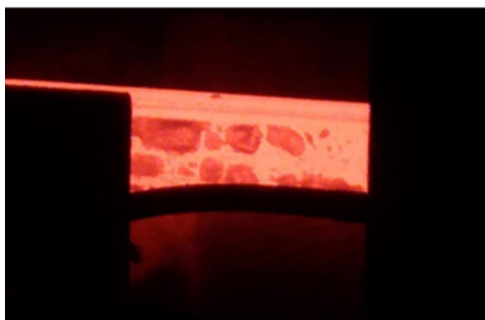
Fig.13. Incomplete descaling of billet and rolls to form seams.

When a heated billet comes out of the furnace, its surface will be covered in a layer of scale. However, if the scale on the billet surface isn't removed completely, it would roll into form seam defects during the subsequent rolling process, as shown in Figure 13. To confirm the existing descaling performance, we used high-pressure descaling nozzles to scour an aluminum plate and observe the erosion marks, as shown in Figure 14. It was found that the erosion marks in some areas were

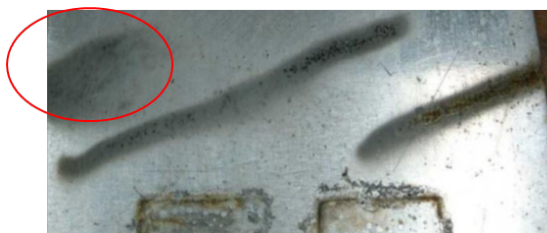
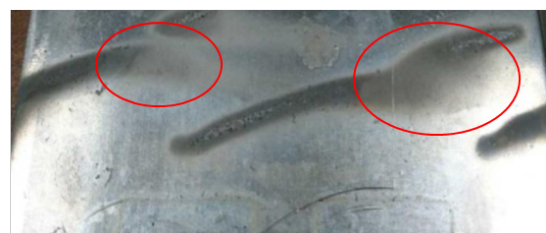
Fig.14. Descaling performance test.

blurred and not concentrated, so it is speculated that the water columns interfere with each other, and the configuration of the descaling nozzles needs to be improved.
