# Design and Welding of Nodes for Offshore Foundation

TZE-CHING YANG, MING-FENG CHIANG and TSAI-SHANG HUANG

*Iron and Steel Research & Development Department  
China Steel Corporation*

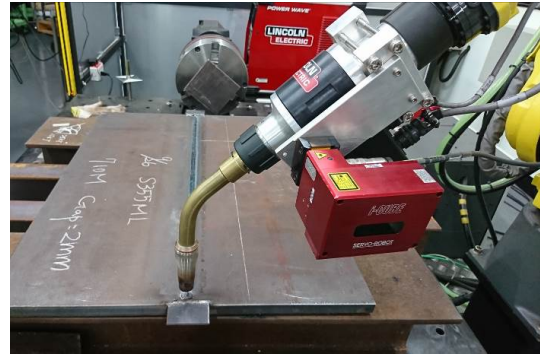
**Fig.5.** Lincoln S-500, combined with a Fanuc M20iA robot, performs welding in the laboratory.

connected to a Fanuc M20iA robot was used to perform welding. Figure 5 shows a welding sample simulated in the laboratory. UT tests were performed to locate defects. Cross sections of the welds were also prepared for metallographic analyses. By comprehensively testing and examining the defect rates, mechanical properties and microstructures, the effects caused by the welding wires can be revealed and a better welding quality can be achieved.

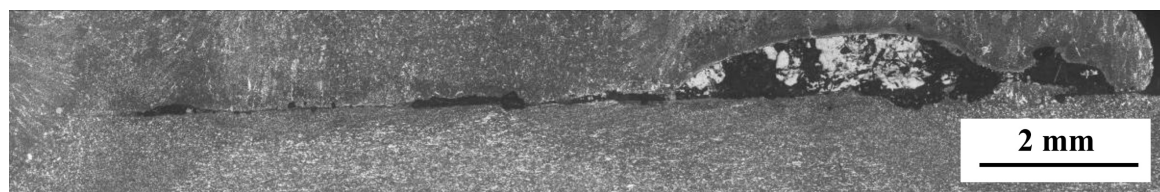
As shown in the micro-metallographic of the poor fusion zone (Figure 7, of the yellow area in Figure 6), it is quite obvious that these defects are mainly slag inclusions and poor fusion at the welding interface. The EDS analysis indicates that Ti, Al, O, Si rich inclusions deposit along the micro crack in the poor fusion zone (Figure 8). This contamination usually comes from the residual slag caused by FCAW process. Normally, slag should be completely removed before another welding pass is applied. However, due to the limited space caused by the small angle between the two welding objects, it is difficult to remove the slag completely and it may be that some is left. Residual welding slag usually accumulates

**Fig.7.** Micro-metallographic of the poor fusion zone indicated in the yellow box area in figure 6.
