# Design and Welding of Nodes for Offshore Foundation

TZE-CHING YANG, MING-FENG CHIANG and TSAI-SHANG HUANG

*Iron and Steel Research & Development Department  
China Steel Corporation*

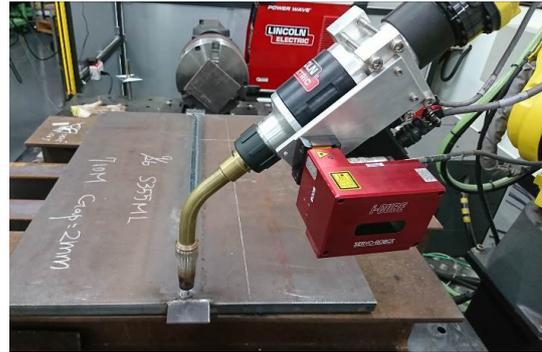
**Fig.5.** Lincoln S-500, combined with a Fanuc M20iA robot, performs welding in the laboratory.

connected to a Fanuc M20iA robot was used to perform welding. Figure 5 shows a welding sample simulated in the laboratory. UT tests were performed to locate defects. Cross sections of the welds were also prepared for metallographic analyses. By comprehensively testing and examining the defect rates, mechanical properties and microstructures, the effects caused by the welding wires can be revealed and a better welding quality can be achieved.

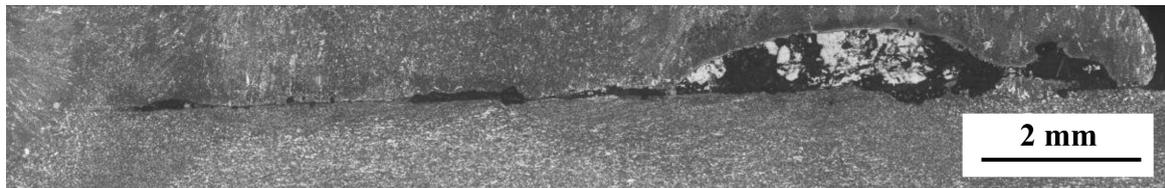
Fig.7. Micro-metallographic of the poor fusion zone indicated in the yellow box area in figure 6.

As shown in the micro-metallographic of the poor fusion zone (Figure 7, of the yellow area in Figure 6), it is quite obvious that these defects are mainly slag inclusions and poor fusion at the welding interface. The EDS analysis indicates that Ti, Al, O, Si rich inclusions deposit along the micro crack in the poor fusion zone (Figure 8). This contamination usually comes from the residual slag caused by FCAW process. Normally, slag should be completely removed before another welding pass is applied. However, due to the limited space caused by the small angle between the two welding objects, it is difficult to remove the slag completely and it may be that some is left. Residual welding slag usually accumulates
