Production Technologies for High-Quality SAE-9254 Spring Steel

*Metallurgical Department
China Steel Corporation*

SAE 9254 is commonly used for automotive suspension springs, requiring strict surface quality to ensure fatigue performance. In collaboration with downstream customers, slip-marks between rings and rust-induced pitting were identified as the primary causes of Eddy Current Testing (ET) alarms. Slip-marks, caused by ring-to-ring contact during strapping, were reduced by increasing lubricant concentration and optimizing strapping pressure. Rust, resulting from thin and FeO-rich scale, was mitigated by raising the laying temperature and slowing conveyor speed, increasing scale thickness from 4 μm to 10 μm and improving the FeO/Fe₃O₄ ratio from 3.0 to 2.3. Above improvements raised the ET pass rate from 51% to 85%, exceeding competitor levels and improving the customer's wire drawing efficiency by 13.6%.

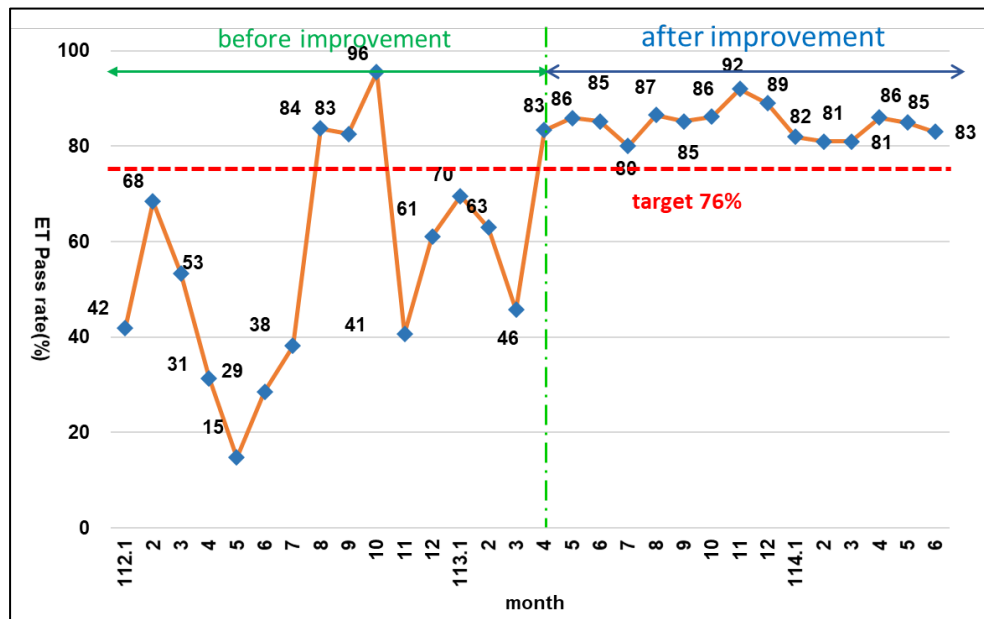
Fig.12. Improvement Trend of ET Pass Rate for SAE 9254.

After applying the improvement measures, the ET inspection pass rate increased from 51% to 85%, as

shown in Figure 12. Moreover, the pass rate exceeded the target level of 76% equivalent to competitor P's benchmark. These results confirm the effectiveness of the countermeasures and demonstrate a stable and significant enhancement in product quality.
