# Failure Analysis of Coating Adhesion: Peeling of Internal Oxidation Layer over Electrical Steel after Stress Relief Annealing

New Materials Research & Development Department  
China Steel Corporation

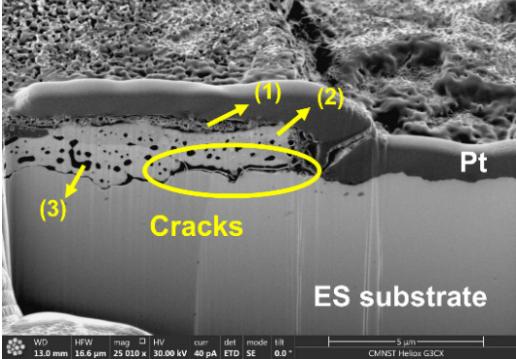
**Table 1** Elemental analysis of the peeled-off sample determined by EDS

In order to understand the composition of each layer, the corresponding analysis of EDS is also provided in Table 1. Firstly, high concentrations of C, O and P were detected in the top layer, which suggested that this layer was the inherent CSC coat. After heat-treatment, the coat showed a porous structure with an average thickness of 0.5 um. It is worth to mention that the coat thickness before heat treatment was 0.7 um. Since the organic parts of the coat were decomposed during heat treatment, the shrinkage of thickness should be reasonable. Secondly, the middle layer was the Internal Oxidation Zone (IOZ), which formed during the heat treatment by the client. It could also be noticed that several particles, which were identified as black dots in SIM image, randomly located in the IOZ structure. The result of EDS showed that blank areas of the IOZ structure was mainly composed of Si and Fe.

SIM cross-sectional image	Element (wt%)	Spot 1	Spot 2	Spot 3

C	3.60	-	1.07
	O	10.98	-	6.76
	Al	1.33	-	2.54
	Si	3.24	1.06	6.08
	P	6.67	-	-
	Mn	2.21	-	1.42
	Fe	71.97	98.94	82.13
