Investigation and Improvement of Molten Zinc Corrosion of a Sink Roll with Thermal Sprayed WC-Co Coating

*Green Energy & System Integration Research & Development Department,
China Steel Corporation*

Surface treatment for sink rolls in a continuous galvanizing line is an important issue due to the hostile environment of the molten zinc. This study investigated the corrosion behavior of the WC-Co coating in molten zinc. Samples with the WC-Co coating were tested in a zinc pot and were cross-sectioned to examine the microstructure and corrosion morphology. The WC-Co coating defects on a used sink roll were also investigated and compared. The results showed that molten zinc intruded through cracks to attack the substrate which caused major destruction of the WC-Co coating. CSC has developed a special process to solve this problem and has greatly improved the service life of a sink roll.

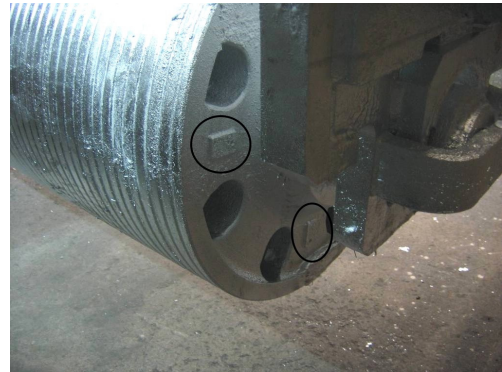
The molten zinc corrosion test was conducted in the zinc pot of a continuous galvanizing line (CGL). Samples were welded to the sides of a sink roll, as shown in Fig.2. They were immersed in the zinc pot along with the sink roll. A testing cycle is from 10 to 21 days, depending on the CGL production schedule or production condition. The aluminum content in the zinc pot is less than 2 %. After each testing cycle, samples along with the sink roll were pickled in a dilute phosphoric acid solution to remove zinc and zinc dross. The surface condition of the sink roll was examined before the next production cycle. If the surface condition was poor, the sink roll would be sent to the spray shop for repair and the samples will be removed to another sink roll for continuing testing. The total testing time of the samples was 42 days before they were sectioned and analyzed.

Fig.2. The circled areas show the testing samples which were welded on a sink roll.

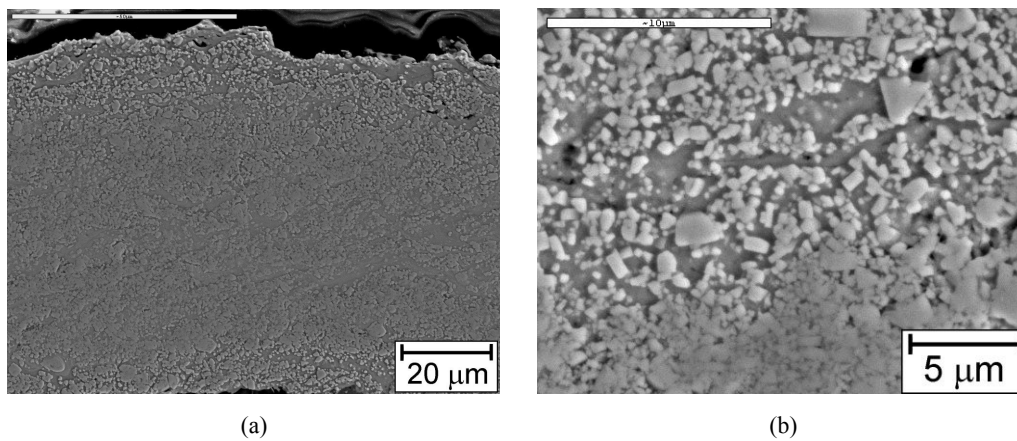
The cross-sectional microstructure of the WC-Co coating is shown in Fig.3. The thickness of the coating is about 75 μ m. WC particles were clearly distributed in

the coating. These hard WC particles reflect on the high hardness of the coating, which was measured as HV 1381. The porosity of the coating is about 0.2%. Thermal sprayed coatings by HVOF usually exhibit dense microstructure with porosity less than 1%. These good coating properties indicated that the spray parameters were suitable for spraying this powder.

Fig.3. Microstructure of the WC-Co coating. (a) Coating thickness is about $75\mu\text{m}$; (b) WC particles are distributed in the coating.

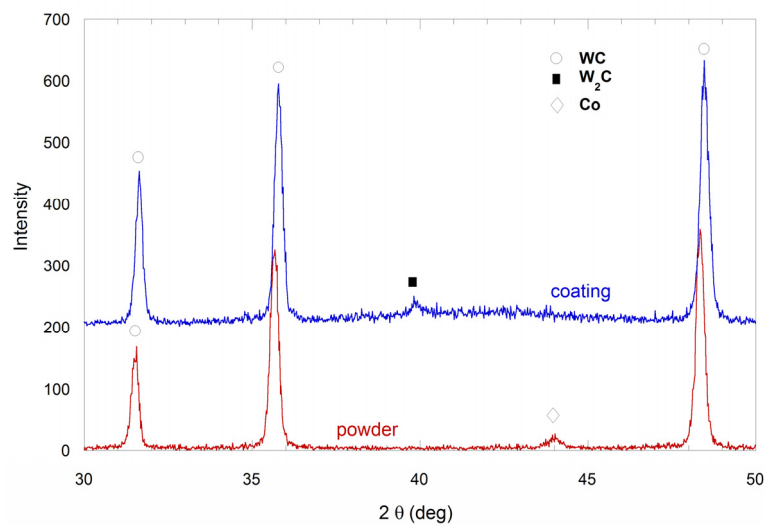
It was reported that the superior corrosion resistance of the WC-Co coating was due to the Co-W-C phase (e.g., $\text{Co}_3\text{W}_3\text{C}$ and $\text{Co}_6\text{W}_6\text{C}$) and the formation of the Co-W-C phase was caused by the reaction of WC and Co⁽¹⁰⁾. Fig.4 shows the X-ray diffraction patterns of the WC-Co powder as well as its coating used in this study. There is Co-W-C phase found neither in the powder nor in the coating. It has been reported that the as-sprayed

WC-Co coating had an amorphous phase form at a diffraction angle of approximately 43° . From Fig.4, there seems to be a shallow and broad peak between 38° and 45° . This amorphous phase is assumed to be the W_2C phase caused by the decarburization of WC during the spraying process^(12,13). It is also reported that with extra annealing at 873K, the amorphous phase is possible to crystallize to $\text{Co}_6\text{W}_6\text{C}$, metallic cobalt and tungsten⁽¹⁴⁾. However, the coating is not treated or used at such a high temperature. The coating in this study is assumed to have no Co-W-C phase included.

Fig.4. XRD analysis of the WC-Co powder and coating.
