Premature Failure Analysis of Mill Rolls at China Steel Corp.

*Plant Engineering & Maintenance Department
China Steel Corporation*

The premature failure of mill rolls can be costly not only due to its high initial cost but also the huge cost of rolling mill downtime. In this paper, a backup roll with a fractured roll neck in a temper and recoil line is investigated. To identify possible root causes, loading patterns of the rolling process, detailed fracture characteristics, and propagation direction of the premature fractured roll were inspected, while a high-stress spot at the roll neck during the normal rolling process was evaluated by the finite element method (FEM). The results revealed that such premature failure was unlikely to be caused by stress behavior under normal rolling, but corrosion pitting pits clustered around the roll neck surface could induce high-stress concentration under such circumstances and facilitate overloading damage. In addition, the corrosive element intruded upon the roll neck surface due to the crevice corrosion between the backup roll and the press-fitted thrust ring was strongly in doubt. The corrosion effect seemed to be accelerated by some obvi

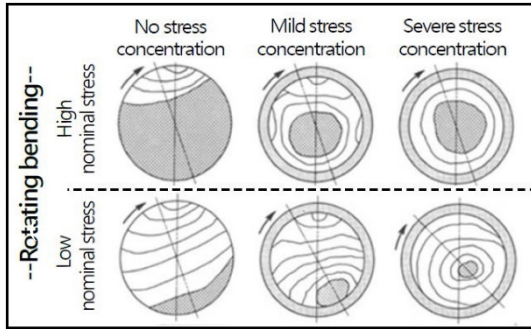
Fig.4. The fractography atlas of rotating bending fatigue.

Using the fractography atlas is another way to determine the root cause. By comparing Figures 3 (a) and (b) to the fractography atlas of the ASM Handbook (Fig.4) and the CSC’s roll failure database (Fig. 5), the premature failure possibility of the backup roll from rotating bending fatigue or internal manufacturing defects could be excluded.

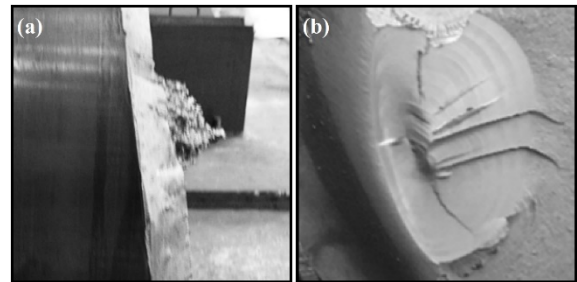
Fig.7. Zoom in the manufacturing defects of Fig.5. (a) and (b)

Additionally, the fracture appearance also provided another piece of evidence to enhance the inference that premature failure didn’t result from rotating bending fatigue fracture or manufacturing defects inside the roll. In rotating bending fatigue fracture, the surface will not present a single angle, it will start at the outer diameter circumference, propagate toward the center, and show a rapid fracture area, as shown in Figure 5. When the roll fails due to manufacturing defects, the fracture surface won’t present a plain surface, it will have a large variation at the initial point (Fig.7. (a)) and may find the arrest mark like the beach mark, as shown in Figure 7 (b).
