Detection of Mold Level Fluctuation in the Continuous Casting Process with Thermal Image and Surface Disturbing Evaluation

HUNG-JU CHANG*, MING-HUNG CHEN* and Yi-FEI REN**

***Steelmaking Department, China Steel Corporation*

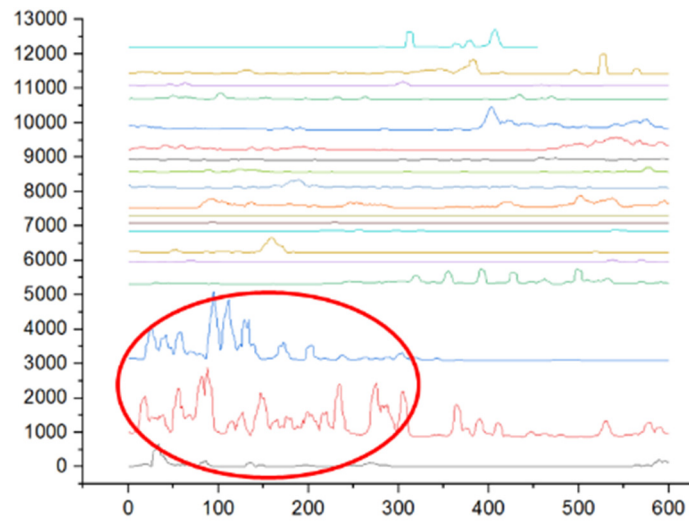
Fig.3. The calculation results of the surface disturbing evaluation.

A much clearer image of the mold surface can be gotten by using the thermal camera, and the fluctuation of the mold level is easily observed. The first thing needed to be solved was to automatically analyze the thermal image, if this technique is to be used in the steel mill. The result of the calculation of the surface disturbing evaluation which was developed in this research is shown in Figure 3. The analytical frequency was 25 and the analytical area was at the narrow side of the mold. The fluctuation of the steel mold level was calm for the most part during the casting process. There were some abnormal waves at times which are marked by the red circle, but the eddy current sensor did not show an unusual signal at that same time. Inspection of the slabs found sliver defects at the location of the abnormal signal.

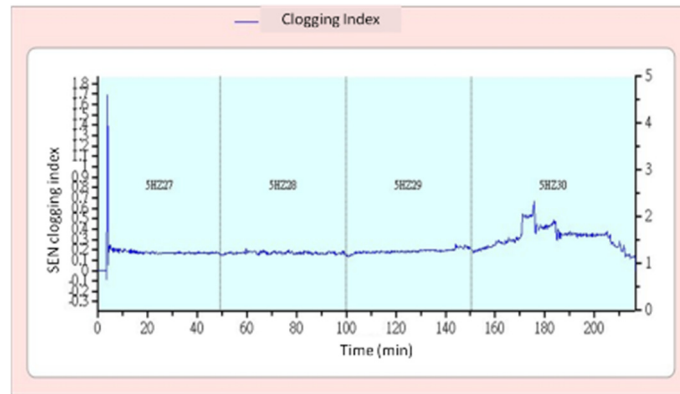
Fig.4. The evolution of clogging index during casting.

In general, the fluctuation of the mold level was small during the casting process, but some abnormal fluctuation could be found by thermal camera. Three different characteristics in the fluctuation of the steel mold surface from the thermal camera are defined in this study. The first abnormal type is caused by SEN clogging. The evolution of the clogging index during the cast

is shown in Figure 4. Using thermal imaging to check this cast, the fluctuation of the mold level was likened to waves on the ocean when serious SEN clogging occurred (the clogging index was raised from 0.2 to 0.6). The cross section of the SEN used in this casting is shown in Figure 5, and some clogging was found at the bottom of the outlet. The CFD method was used to simulate the influence of SEN clogging with the same position, and the results are shown in Figure 6. The turbulent energy of the mold surface with SEN clogging was one time larger than that of SEN without clogging. The higher turbulent energy represented in the fluctuation of the mold level was bigger and the simulation result was similar to the result of the thermal image. It could have been handled early when the fluctuation of the mold level was like waves on the ocean.

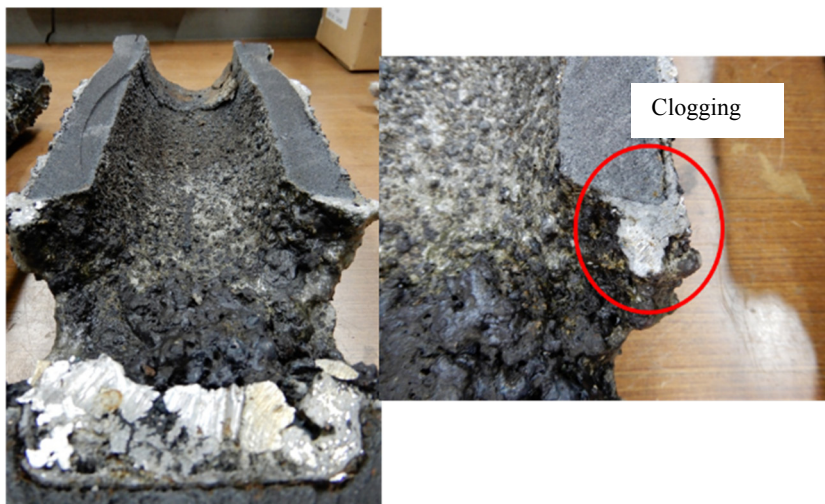
Fig.5. The cross section of SEN with clogging.
